Clearview Home Inspection

Owen Sound
Huntsville, Ontario P2A1T5

Prepared for: Sample

11:40 February 14, 2022

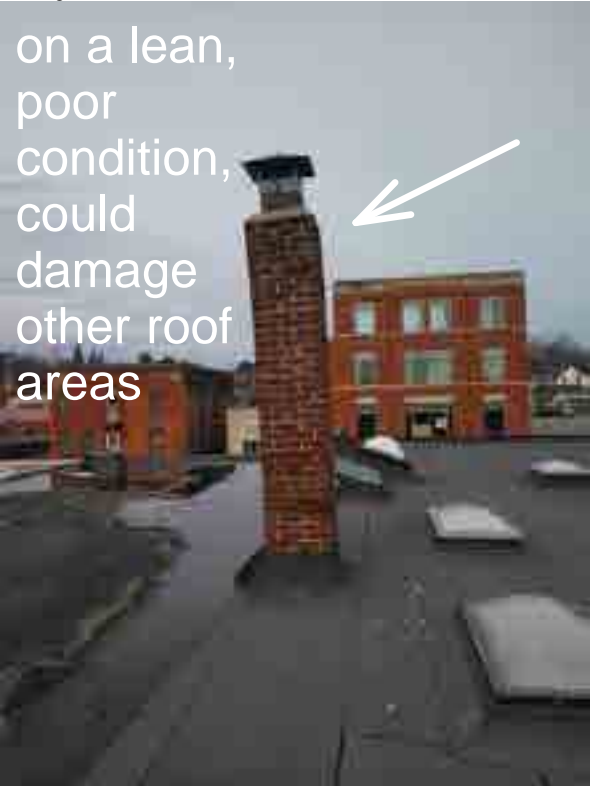
on a lean,
poor
condition,
could
damage
other roof
areas

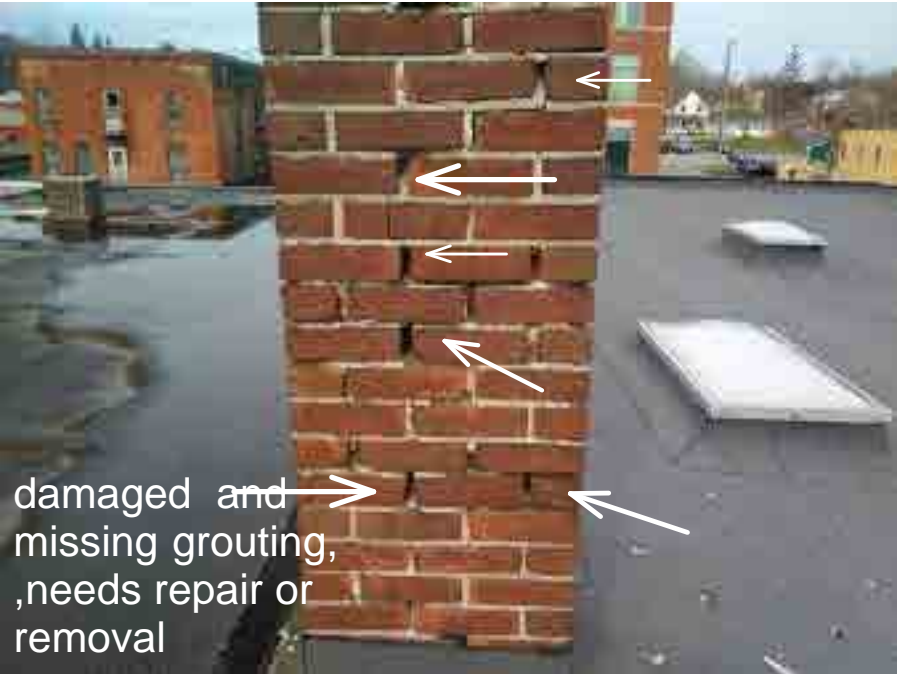
damaged and
missing grouting,
,needs repair or
removal

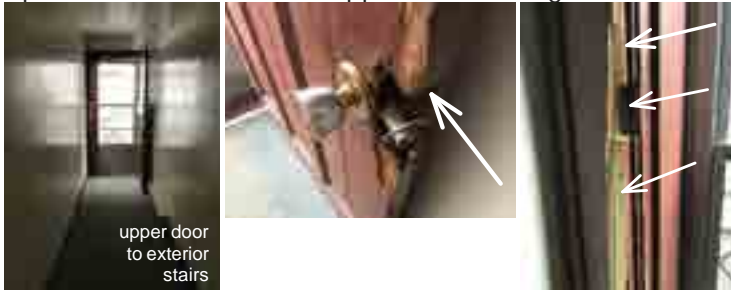
12. Apartment area Stairwell Upper door damage noted

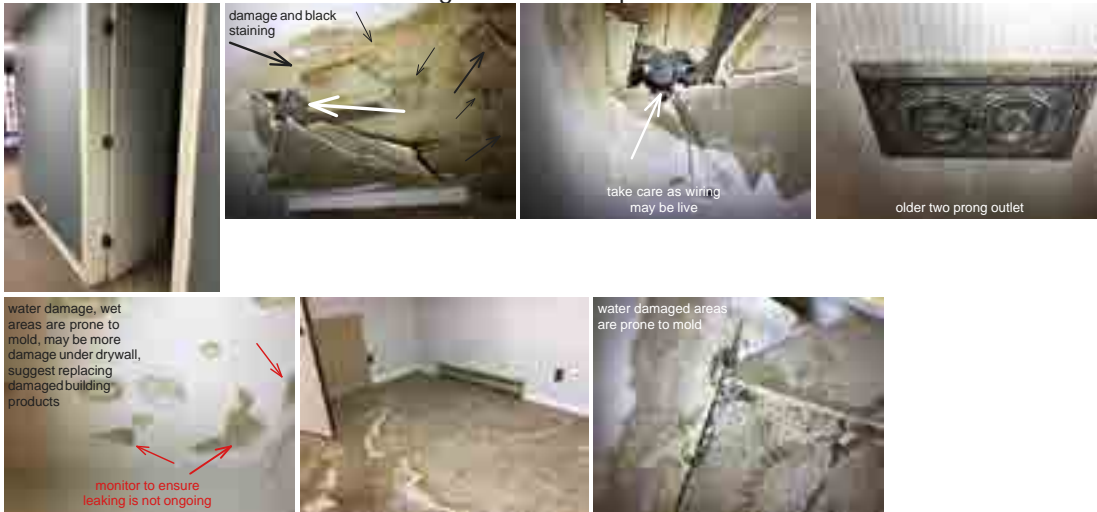
13. rooms Common Area Water damaged room see pictures

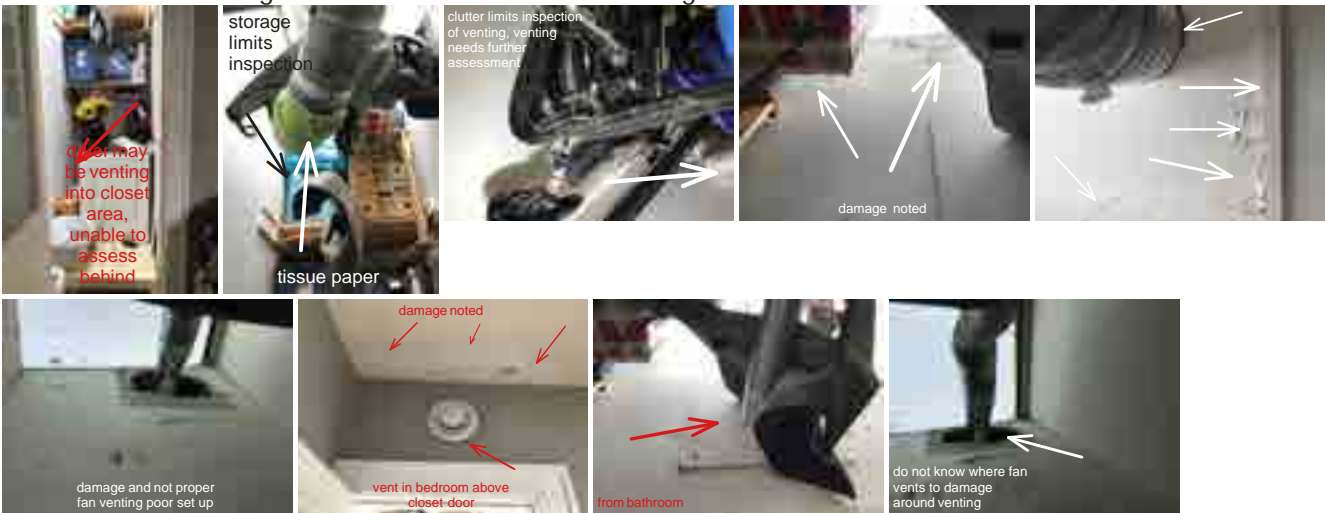
22. Main Bedroom Bathroom ventilation see pictures - area is dirty, kitty litter all over, not proper fan venting, tissue paper wrapped around venting, clutter limits inspection of area, unable to inspect dryer connections or venting, ensure dryer venting is not venting into the closet area as heat and moisture will cause damage, when the area is empty venting needs to be assessed and corrected, cannot confirm where venting goes to, proper venting is to the exterior of the building as heat and moisture will damage areas in the home

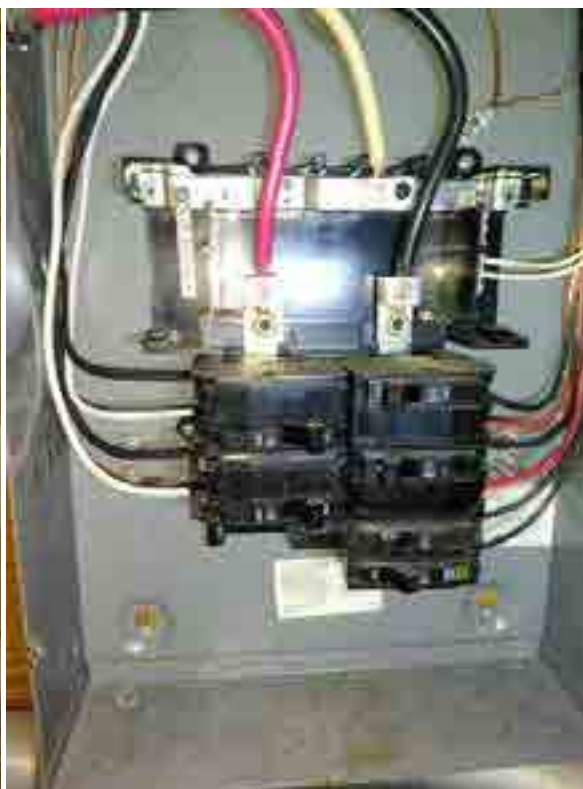
electric
panel for
middle unit
is located in
basement

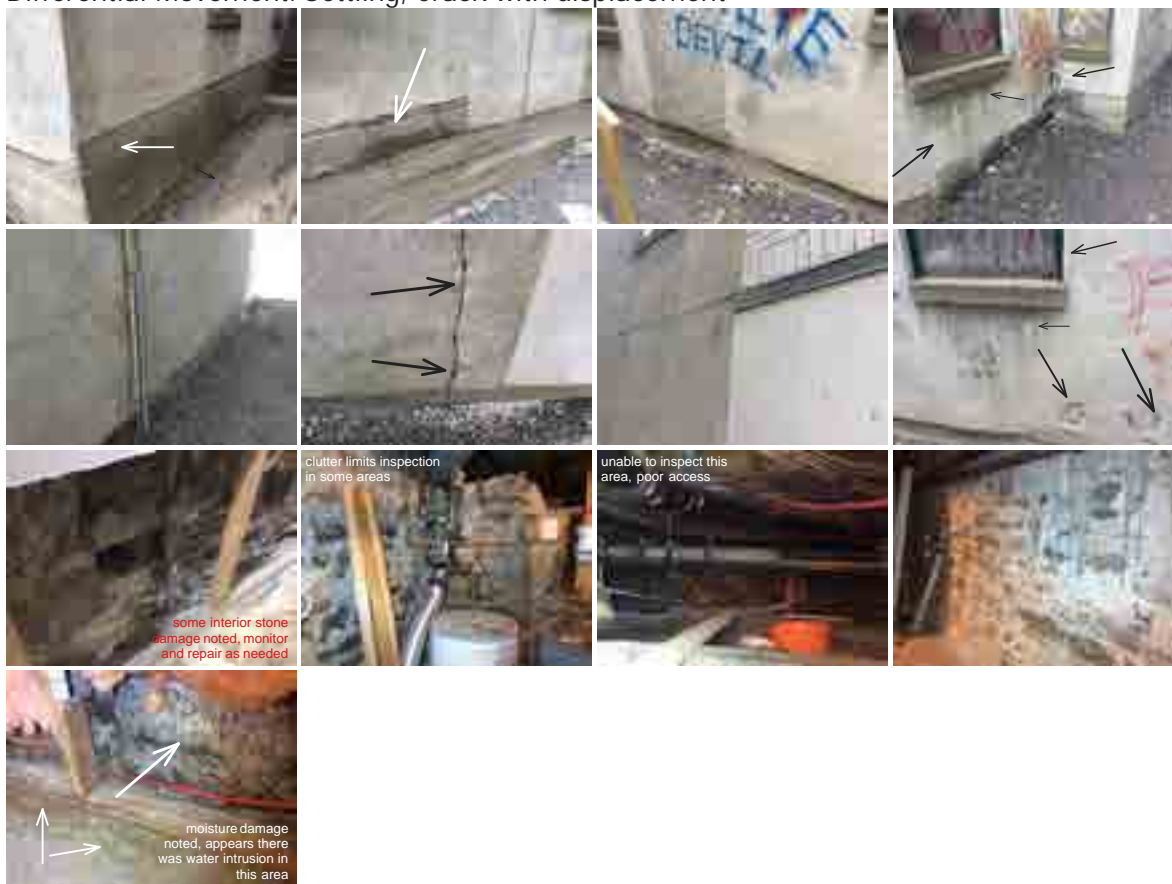
3. Acceptable Differential Movement: Settling, Crack with displacement

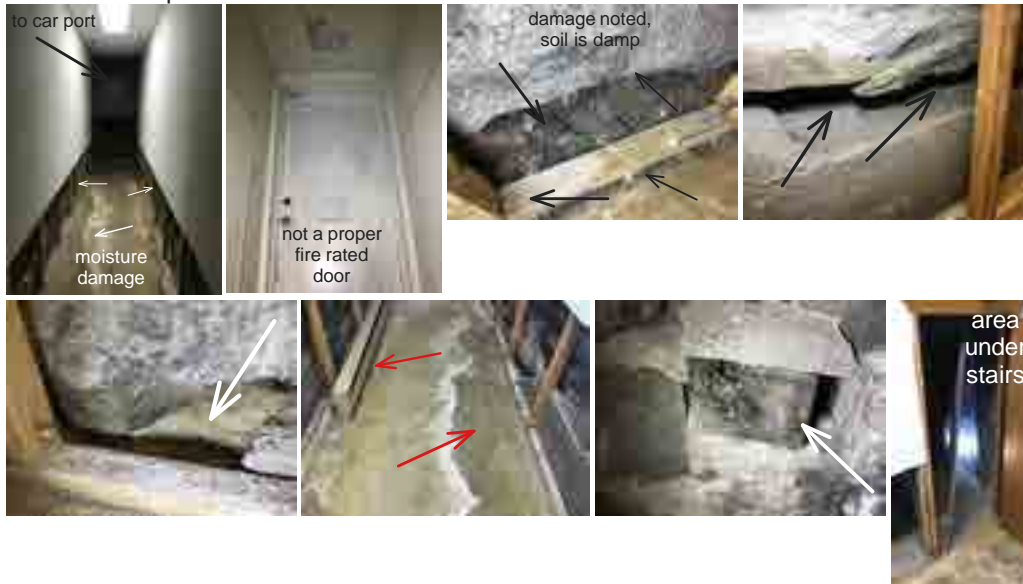
Doors: to carport

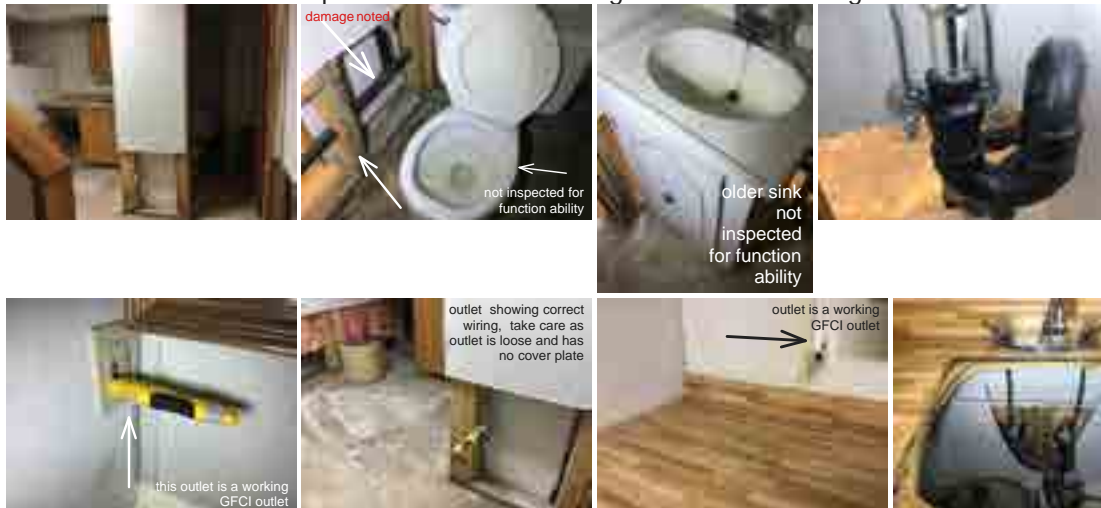
Bathroom/sink area see pictures - marked marginal to note damage

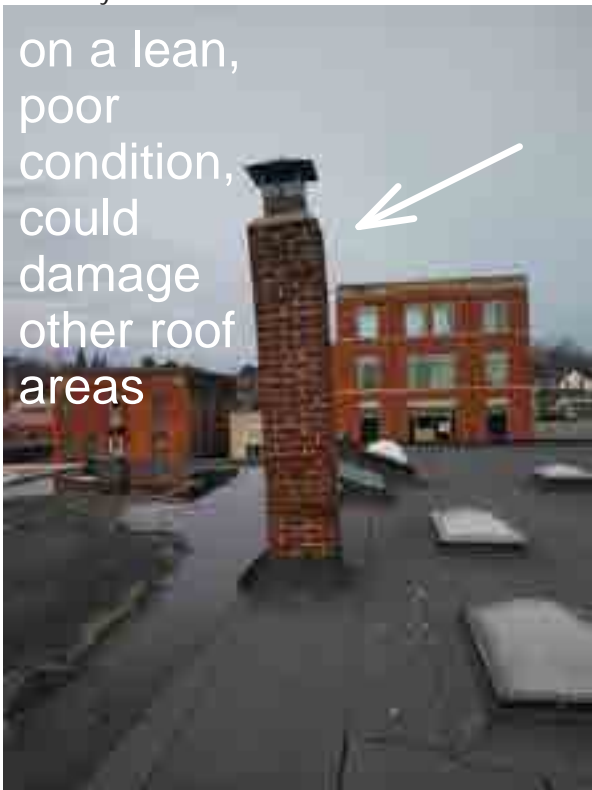
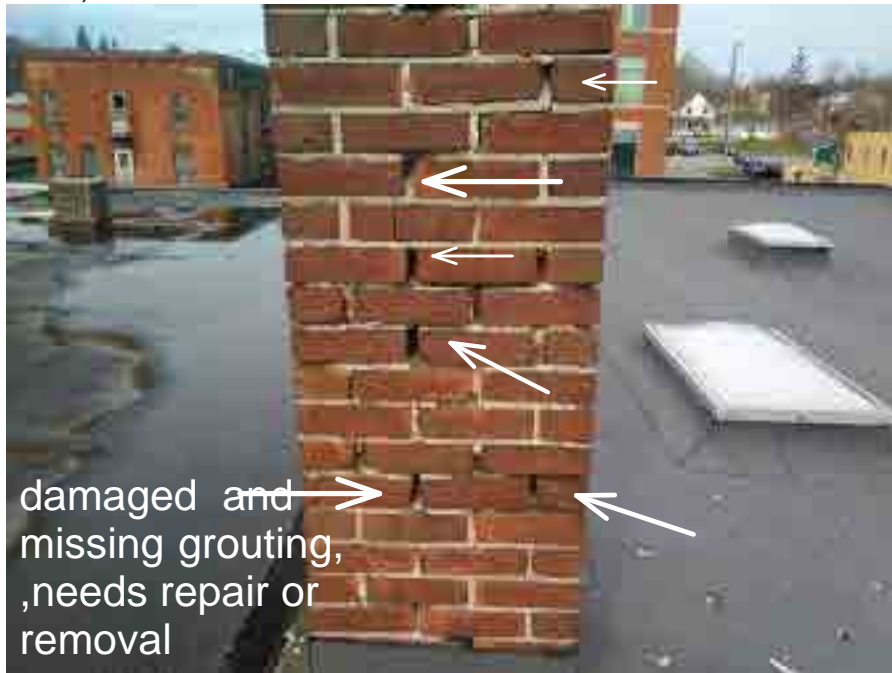
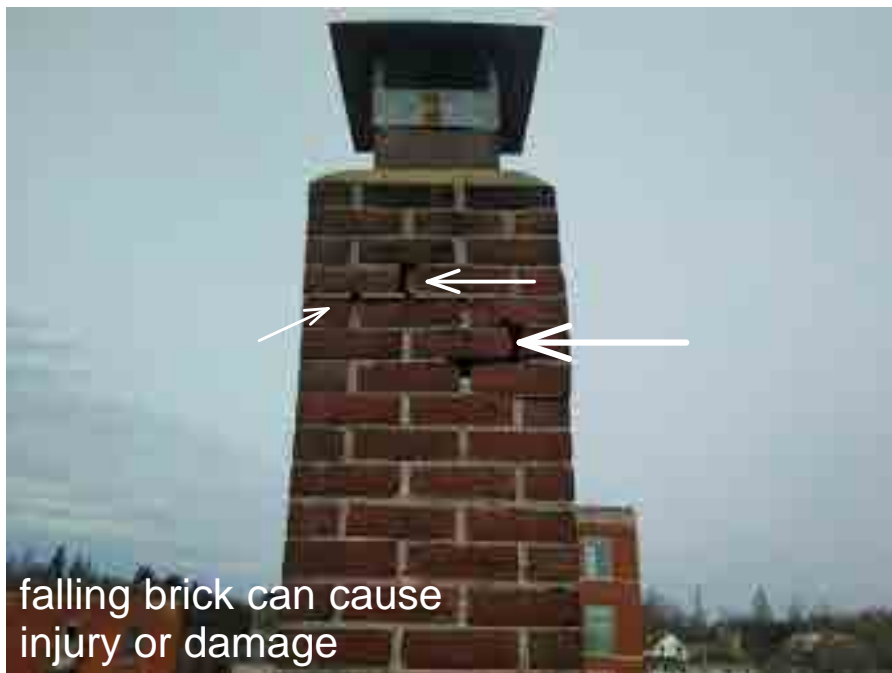
10. Marginal Chimney: Brick

The main roof area is an older rolled roof material. Suggest asking owner for any information on the roof such as age of material, maintenance and upkeep, drainage etc.... The chimney is older brick and is on a lean. Falling brick or a falling chimney can cause damage and injury. The chimney is in need of repair or removal. If the chimney damages the roofing on the neighboring buildings you will likely be responsible for the damage. Skylight windows are in place. Skylight windows will invariably leak at some point so ongoing monitoring of the windows for damage which could lead to leaking will be needed. One skylight window (see body of inspection) had damage leaking and what appeared to be mold present on it. We cannot confirm the presence of mold only point out areas that appear to be mold. The presence of mold and what type has to be determined by lab testing. Lab testing and remediation of any mold issues is likely to be expensive.

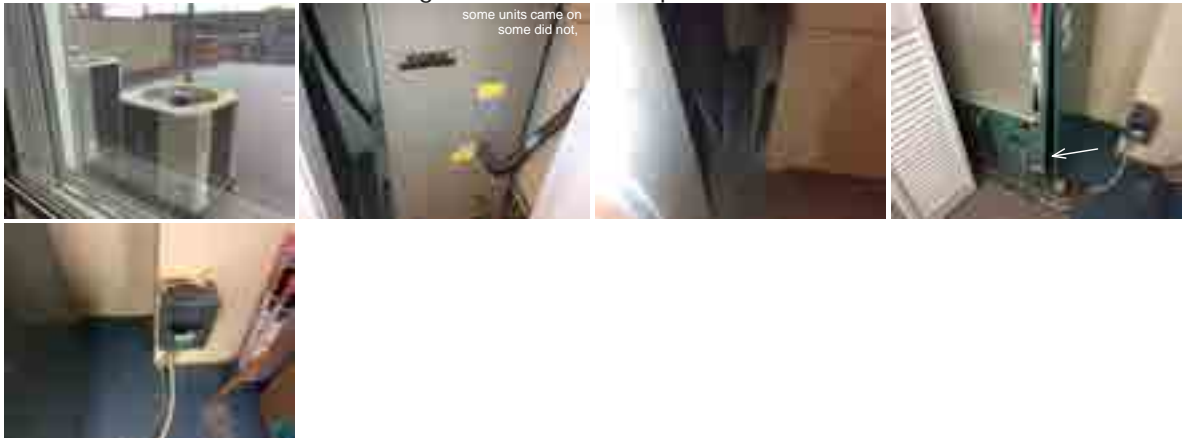
1. Not Inspected A/C System Operation: Appears serviceable - suggest having a heating/cooling contractor inspect the air conditioning system for function ability, damage, cleaning and any needed upgrades, one unit is newer, roof units are sitting in water in some places

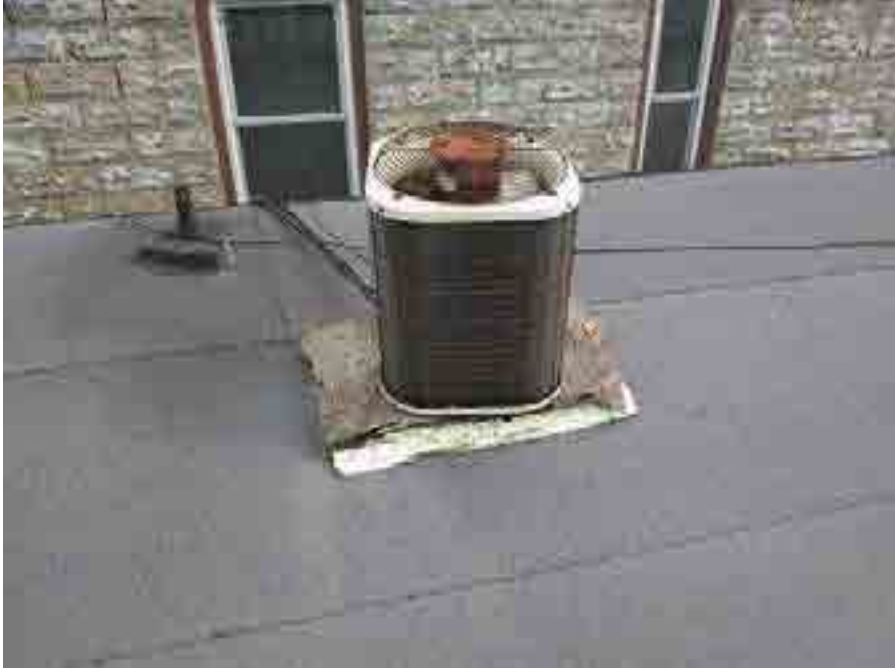
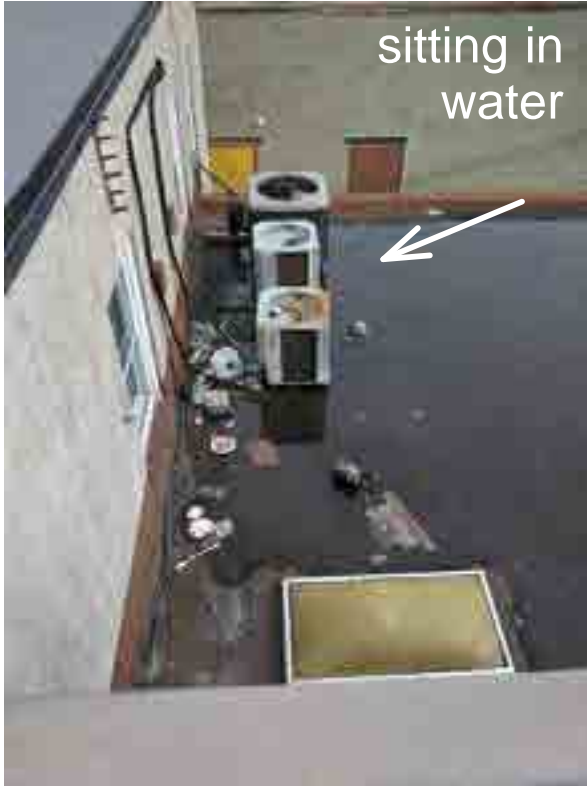
3. Not Inspected Exterior Unit: Sitting in water on the roof

The air conditioning units were not fully inspected. It is the wrong time of year to test air conditioning units. The air conditioning system is older and some units did not come on. The units on the roof are sitting in water. Some damage is noted and some units are dirty. Some of the control units may not be working or need batteries. Suggest having a heating/ cooling contractor inspect the system for function ability, damage, cleaning as there may some expenses if the system needs upgrading or damage has occurred. As the system is older regular maintenance will help prolong the life of the system.

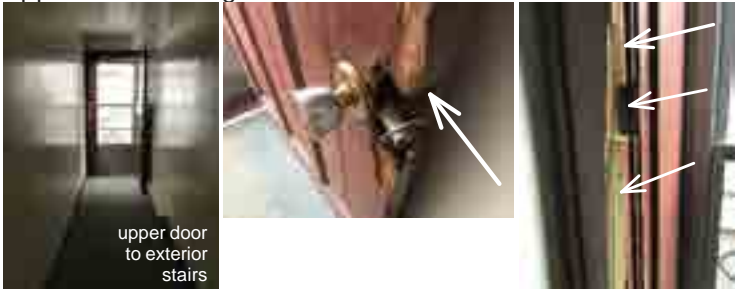
5. Marginal Upper door damage noted

The upstairs hallway has some cracking noted on the walls. Ensure the stair well area remains safe to use and well lit. There does not appear to be emergency lighting. The door to the exterior stair well (fire escape door) has damage and the door frame is damaged. Ensure the fire escape landing remains stable and railings secure as the area is a falling hazard. There are no exit signs over doors.

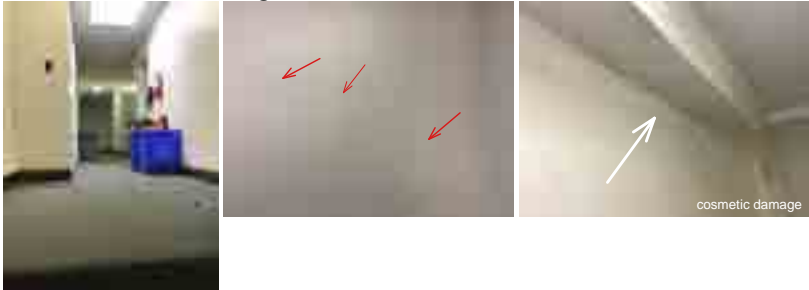
6. Acceptable Walls: some cracking noted

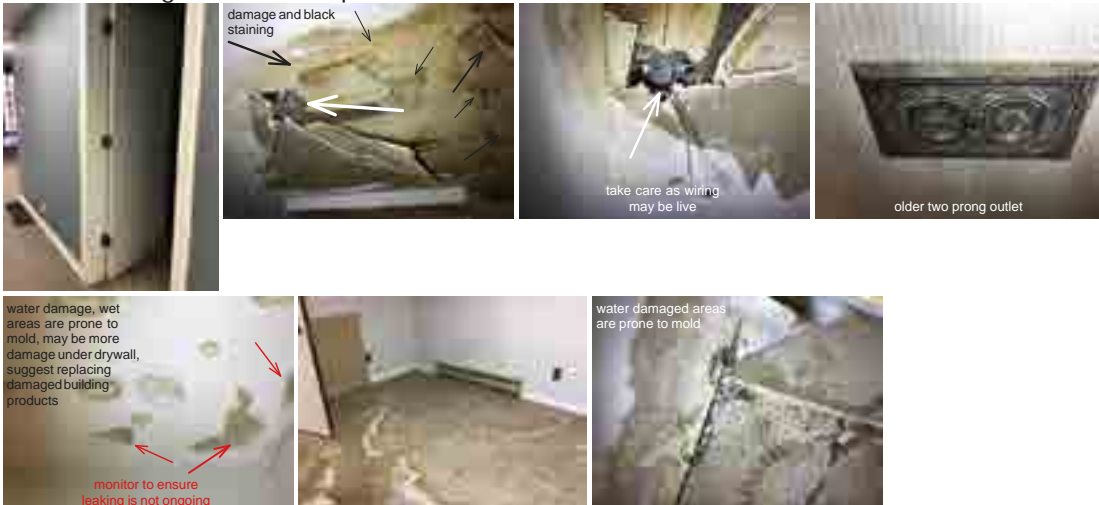
13. Marginal Water damaged room see pictures

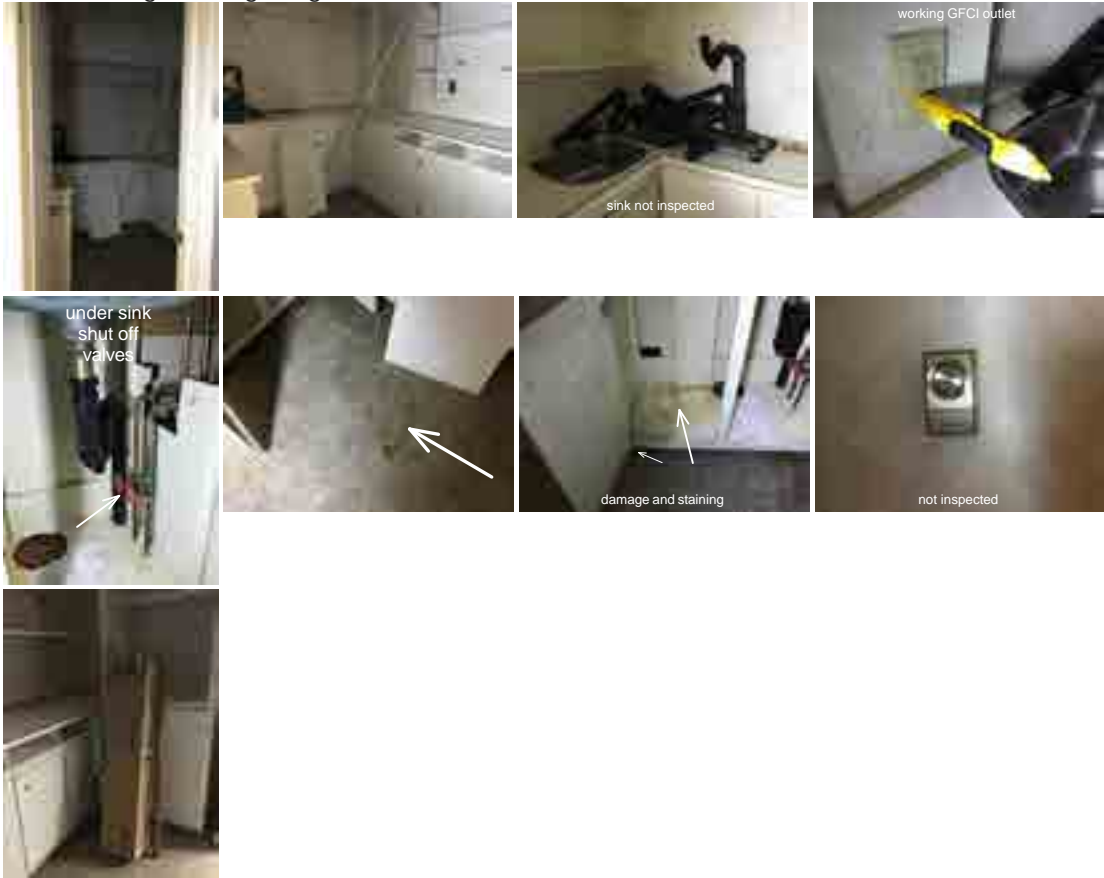
Room on right no lighting in room
