# Clearview Home Inspection

Prepared for: R Wight

Prepared by: Clearview Home Inspection  
21 Worsley Lane  
Nobel , Ontario P0G1G0  
HST # 84475 6890 RT0001

09:39 May 30, 2017

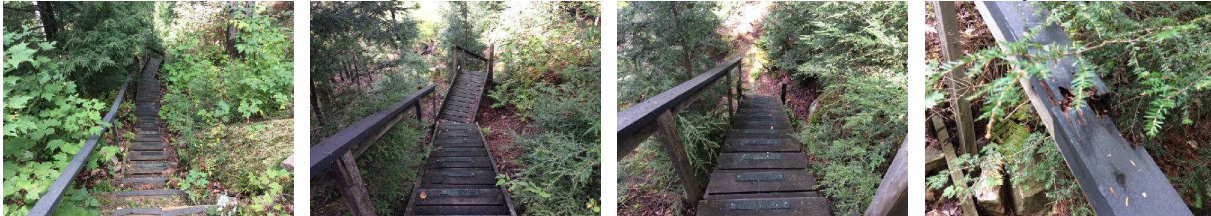
1. Steps/Stoops: Wood steps to water older wood, not built to current standards, falling hazard, maintenance and repair needed

The steps to the water are older, not built to current standards and not safe in their current condition. Take care when using the steps and monitor for safety. The decking is older wood, some maintenance is needed. The deck is not built to current standards and presents a falling hazard. Decking and railings will need ongoing monitoring for safety and stability. The deck does not appear to be properly supported so snow load will have to be monitored and shoveled as needed. In the spring assess all decking, railings and stairs for

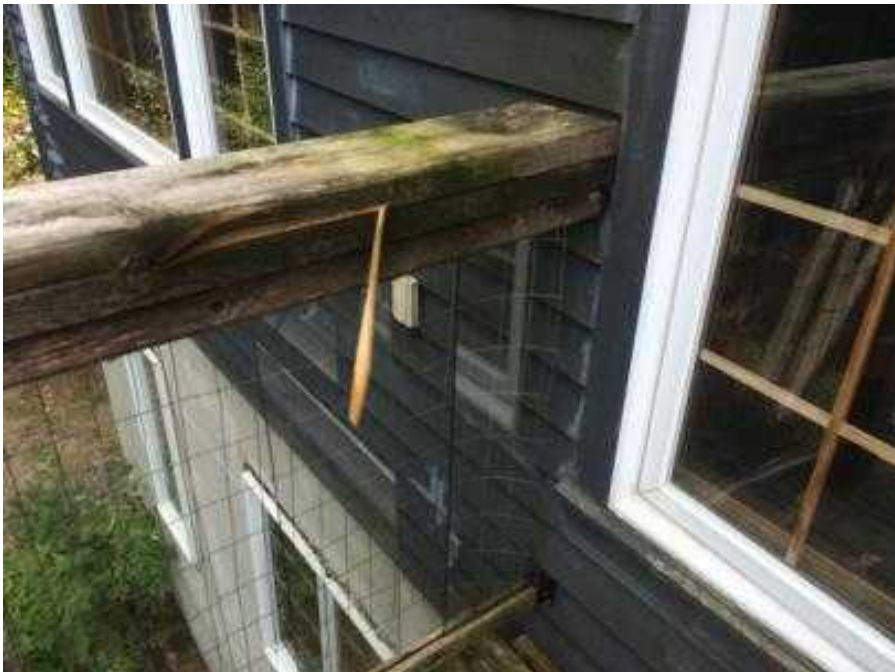
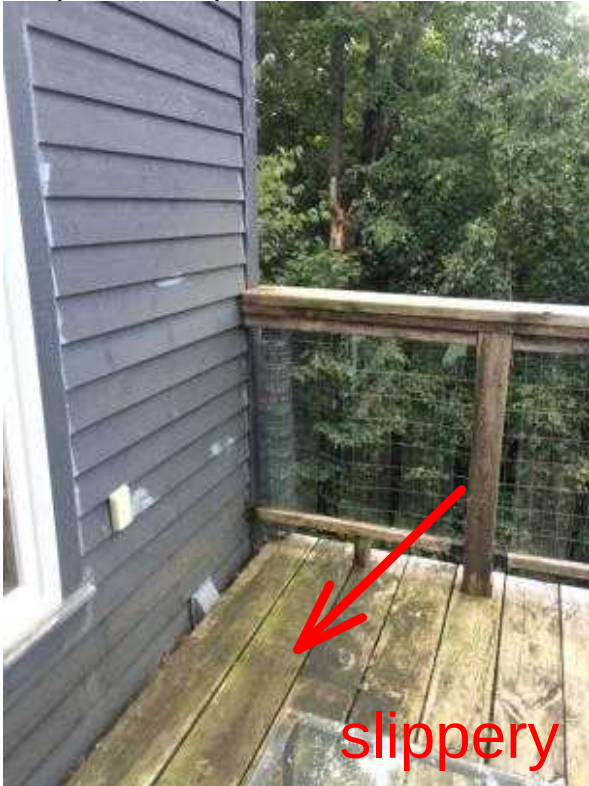
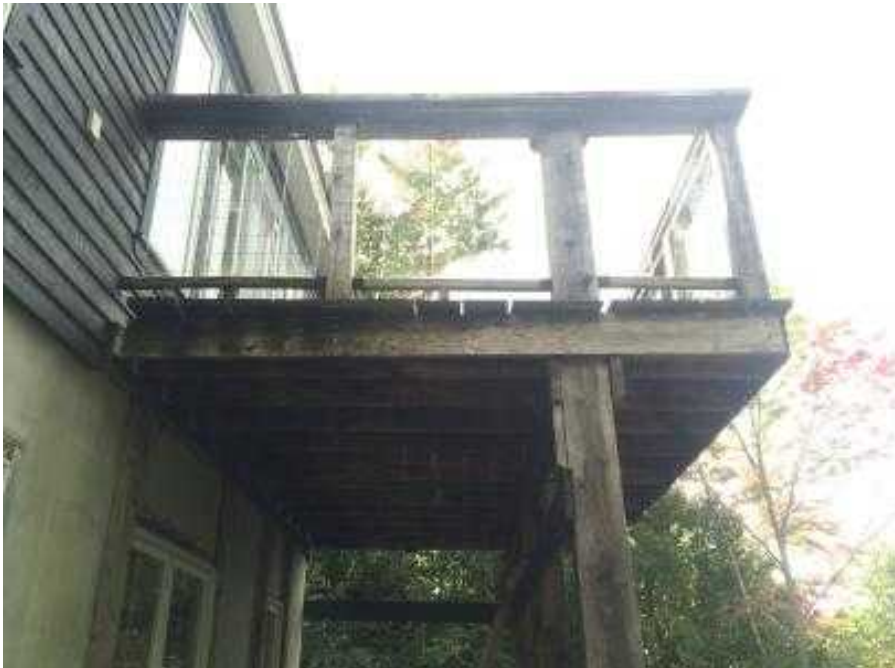
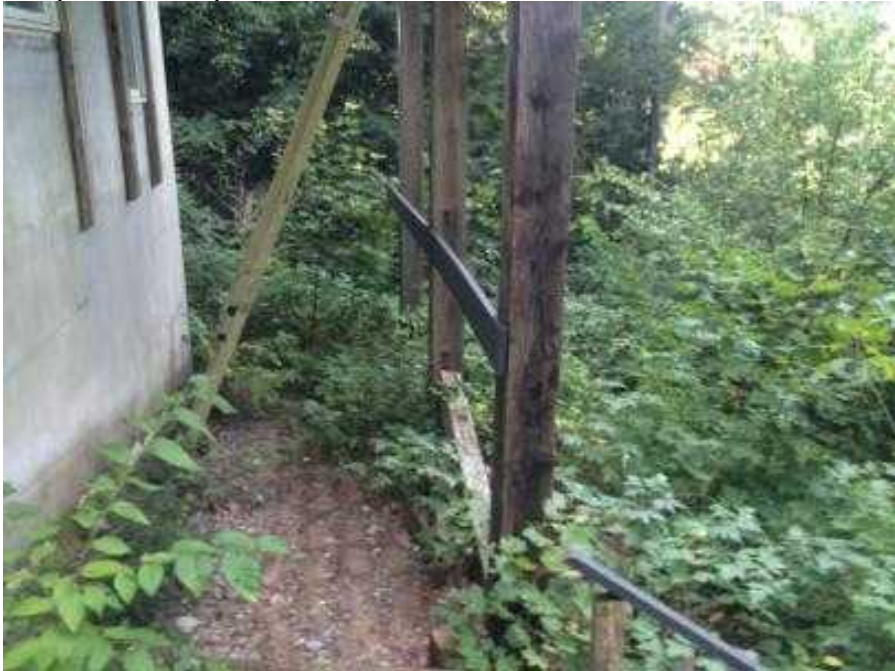
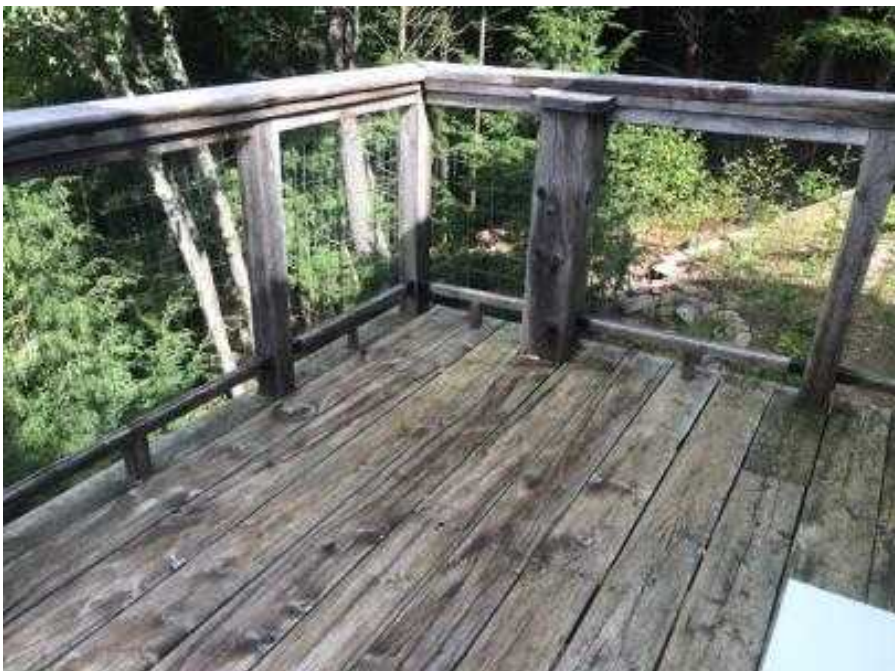
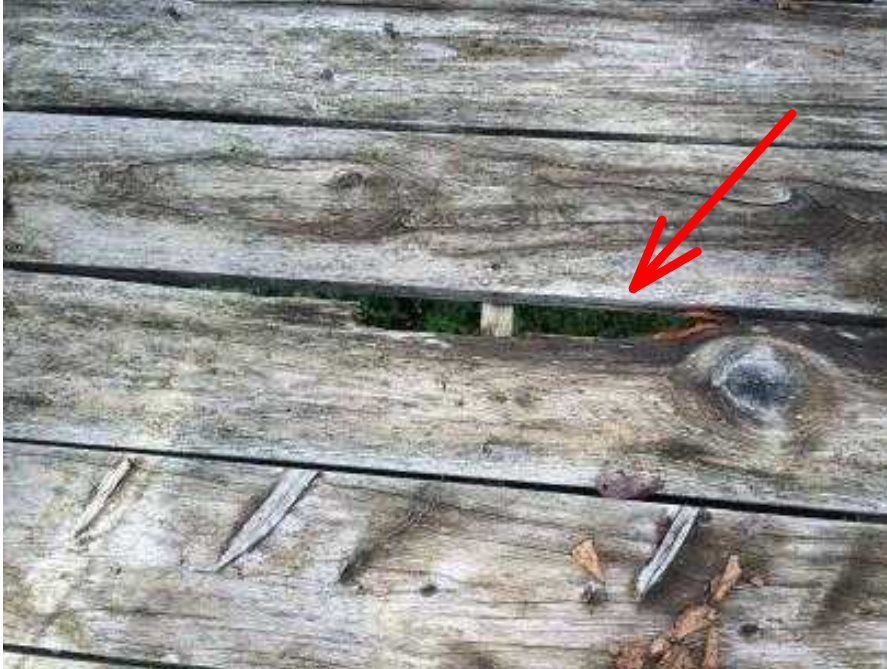
2. Deck: Untreated wood older wood, not built to current standards, does not appear to be properly supported maintenance and repair needed, falling hazard, ongoing monitoring for wood and railing stability will be needed, monitor snow load and shovel as needed

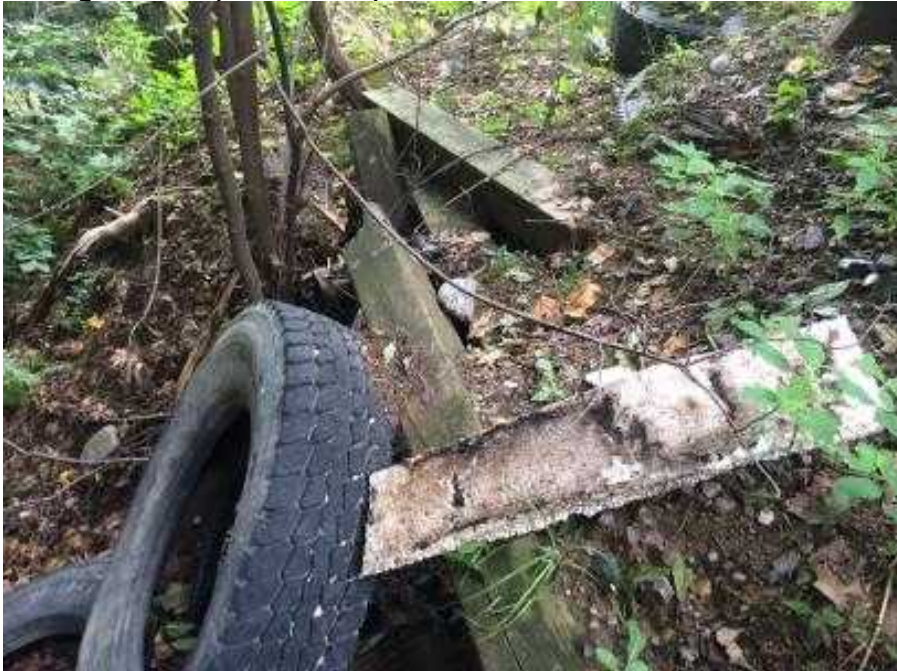
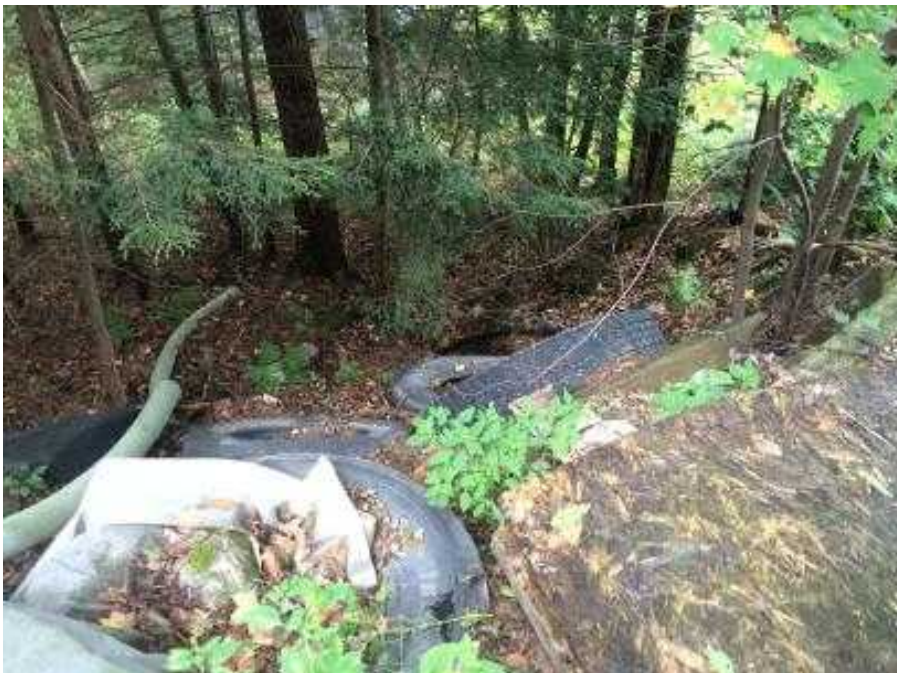
4. Retaining Walls: Rocks and old tires retaining walls are falling apart, suggest repairing the walls, ongoing monitoring and early correction of any issues to prevent a bigger problem

winter damage and repaired prior to use. The retaining walls are falling down in places and are in need some maintenance and repair. Suggest early corrective action with any issues with the retaining wall as you do not want the walls to give way.

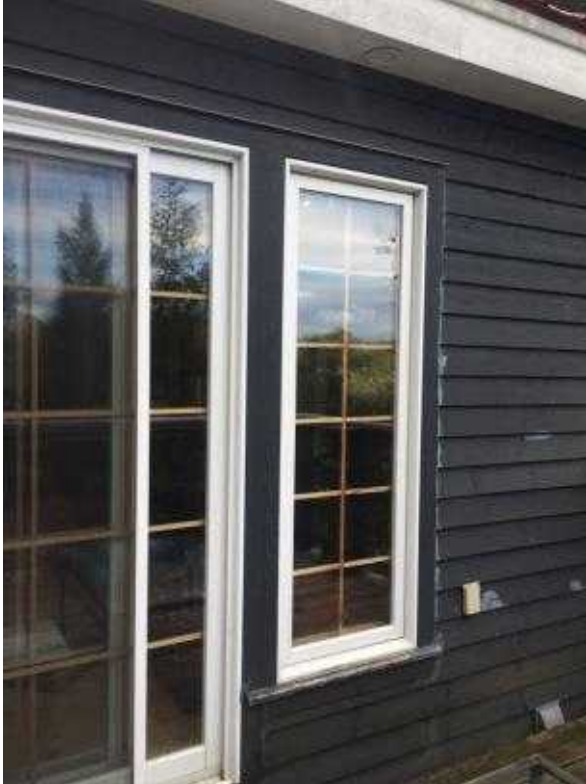
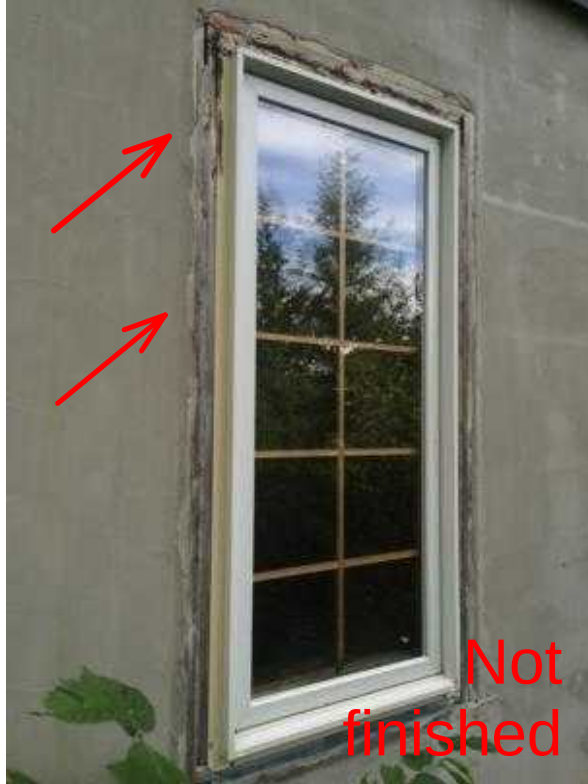
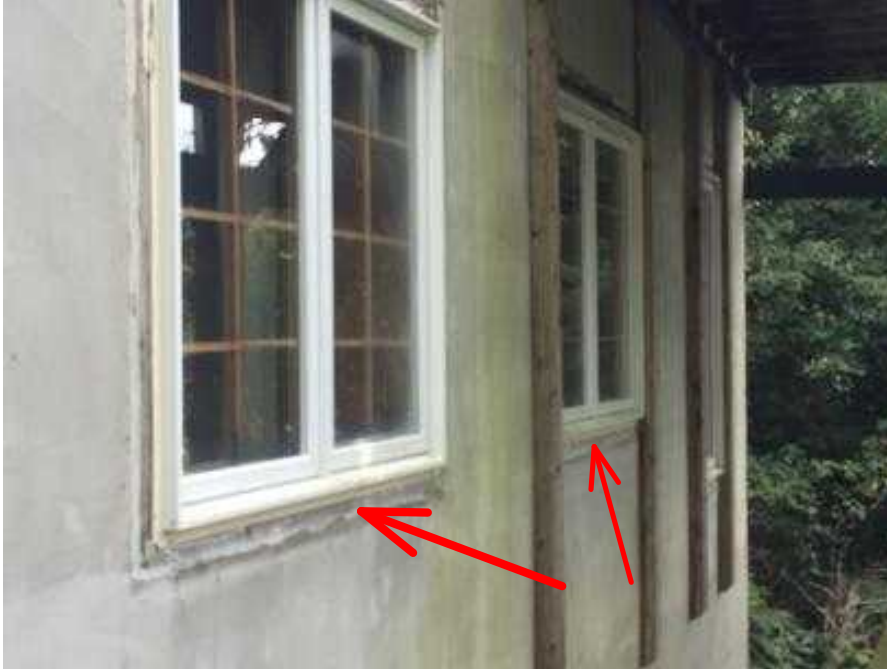
5. Basement Windows: Vinyl not finished and need to be finished as water, rodents and bugs will get behind and cause damage

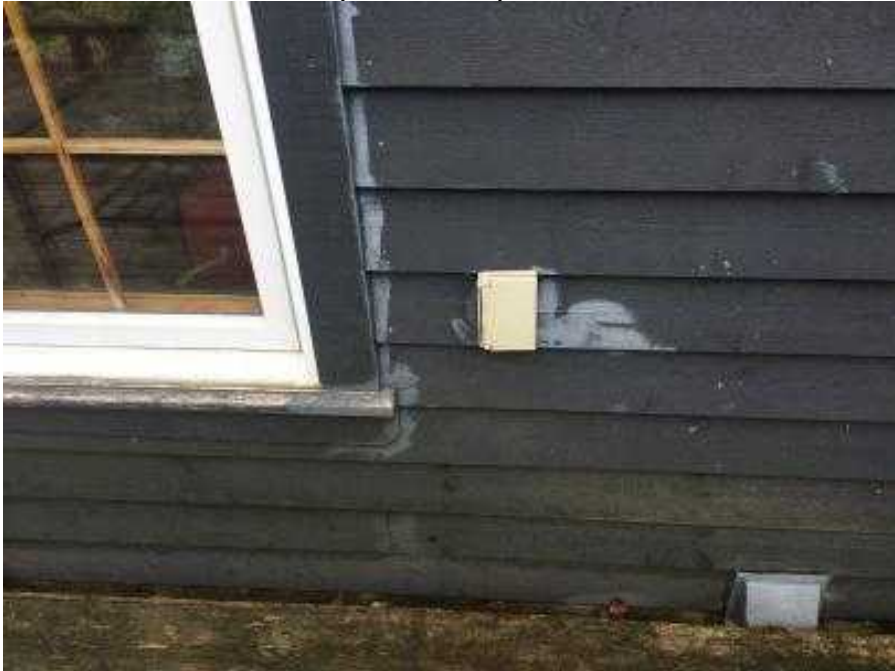
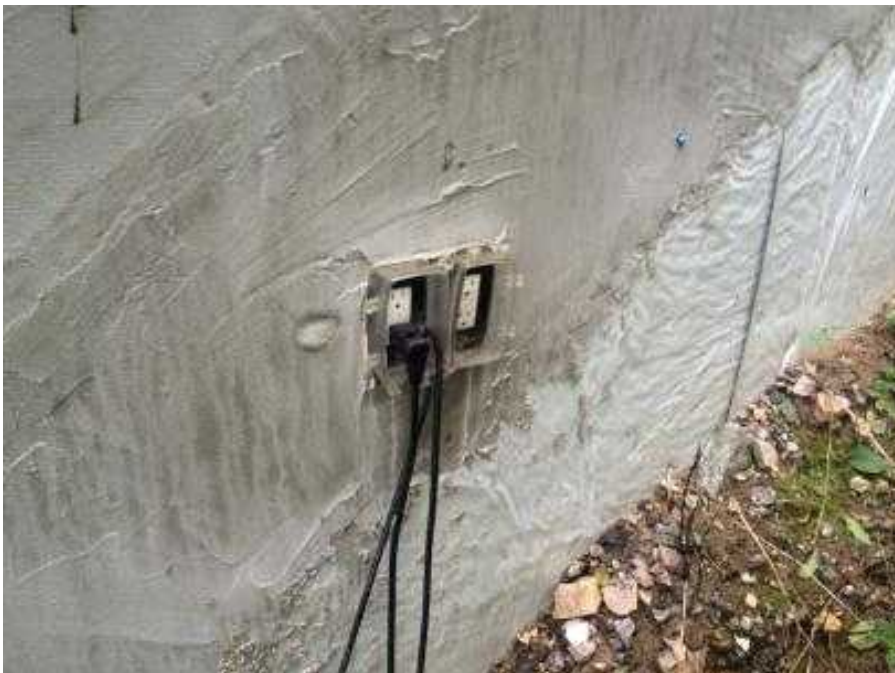
6. Exterior Electric Outlets: 110 VAC GFCI 5 exterior outlets were tested, two GFCI outlets were not tripping and will need replacement, two were not GFCI protected and should be as are exposed to water, one exterior outlet(that the transfer pump was plugged into) was on the same circuit as the furnace so when the pump tripped the breaker the furnace would not come on (discussed at time of inspection)

No issues were noted at the electric panel. There is an extension cord near the panel that is attached to a wiring circuit and this is not proper wiring. 5 exterior outlets were tested, two GFCI outlets were not tripping and will need replacement, two were not GFCI protected and should be as are exposed to water, one exterior outlet(that the transfer pump was plugged into) was on the same circuit as the furnace so when the pump tripped the breaker the furnace would not come on (discussed at time of inspection). The outlet that the washer was plugged into showed incorrect wiring. The outlets along the work bench were showing open ground when tested with the tester. There is some unfinished wiring which should be properly closed off. There is a light under the stairs in the wood shop which is improperly wired and wire is rubbing on

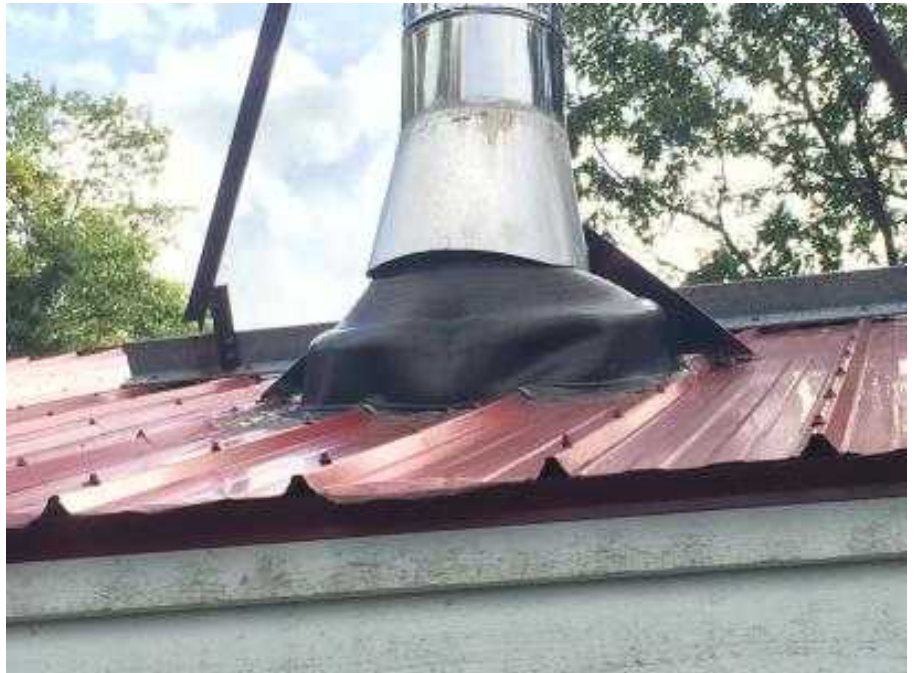
7. North Chimney Chimney Flashing: may not be code compliant have the fireplace contractor assess the flashing to see if it is code compliant

The wood stove could not be WETT certified in it's current condition as it was not code compliant. Suggest having a fireplace contractor assess for options and pricing. Have the contractor make the needed changes and issue a WETT letter at that time. You were not charged for WETT inspection as we could not write the WETT letter.

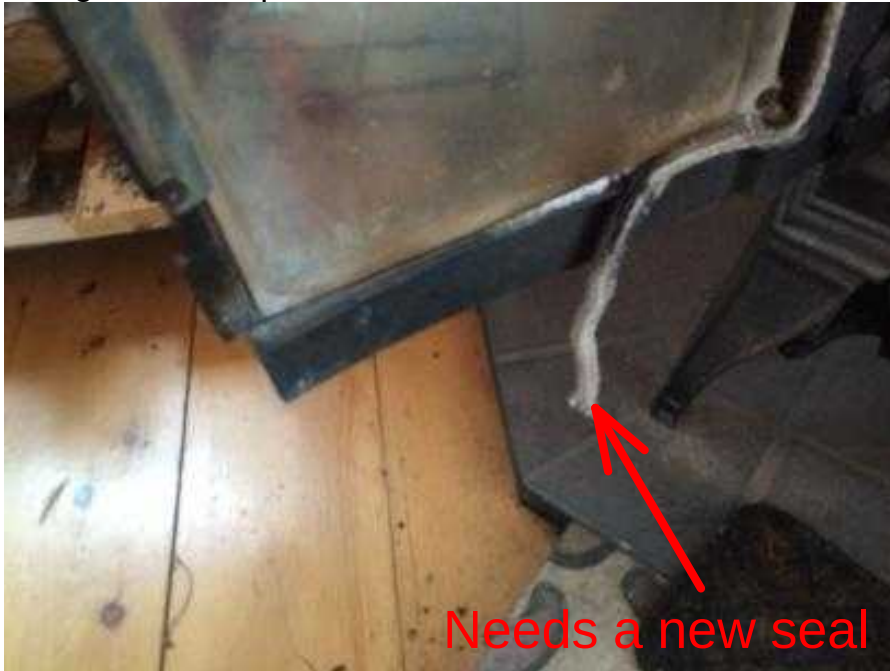
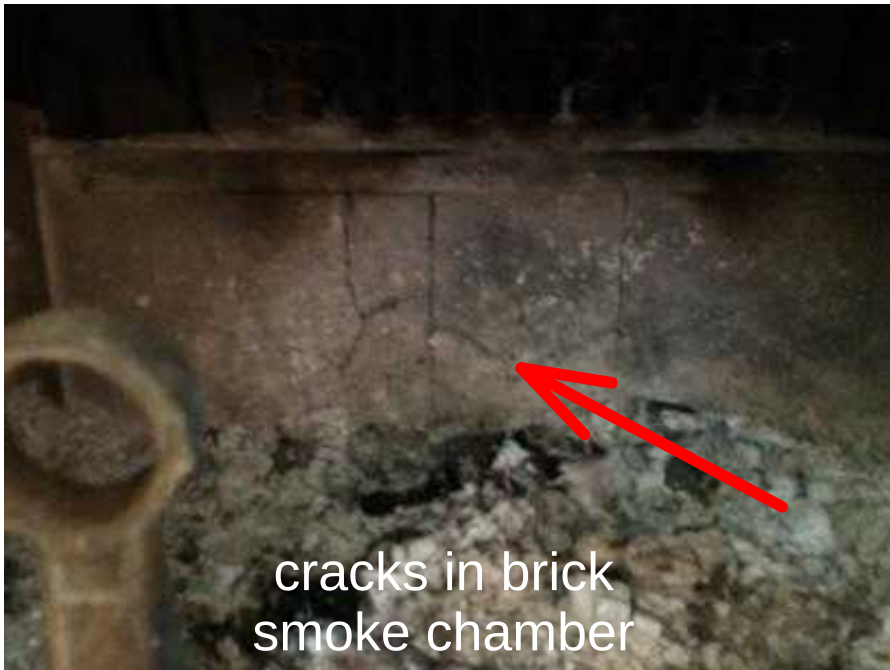
10. Living Room Fireplace Smoke Chamber: Brick

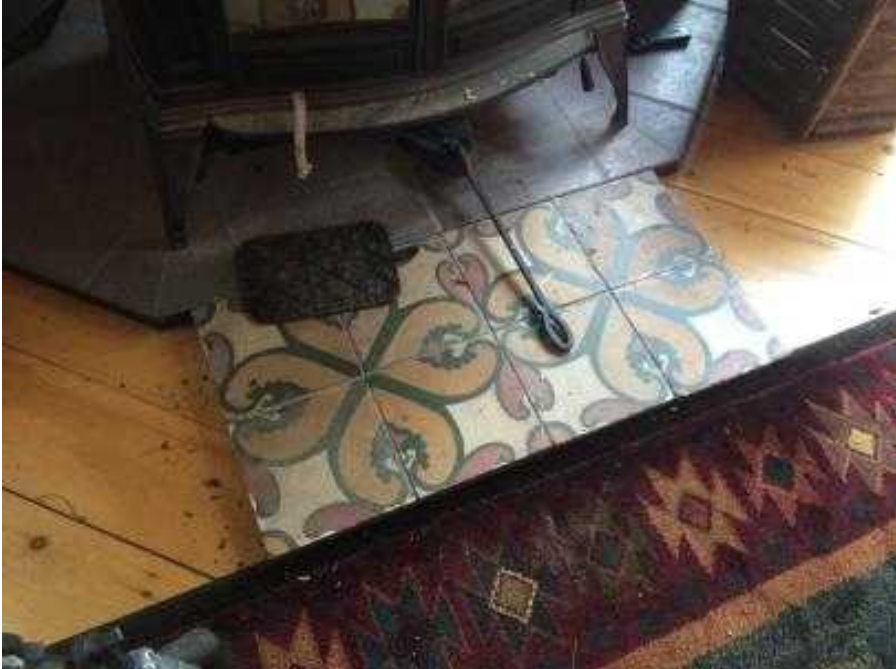
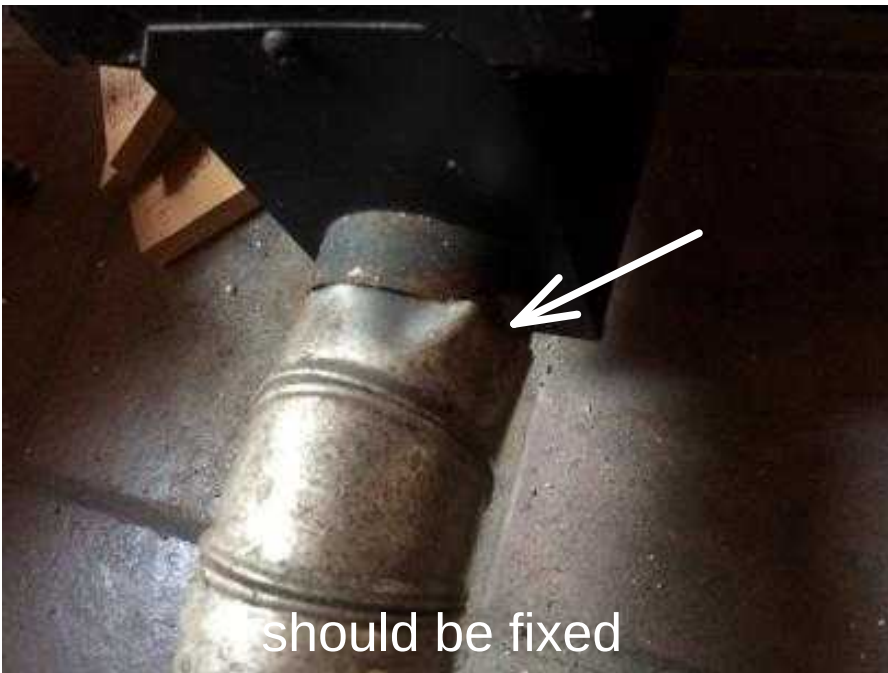
11. Living Room Fireplace Hearth: Raised not code compliant

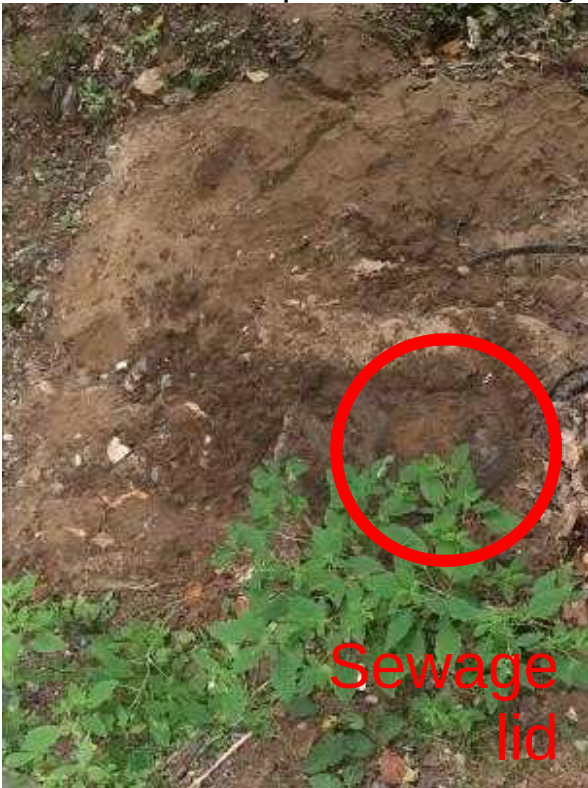
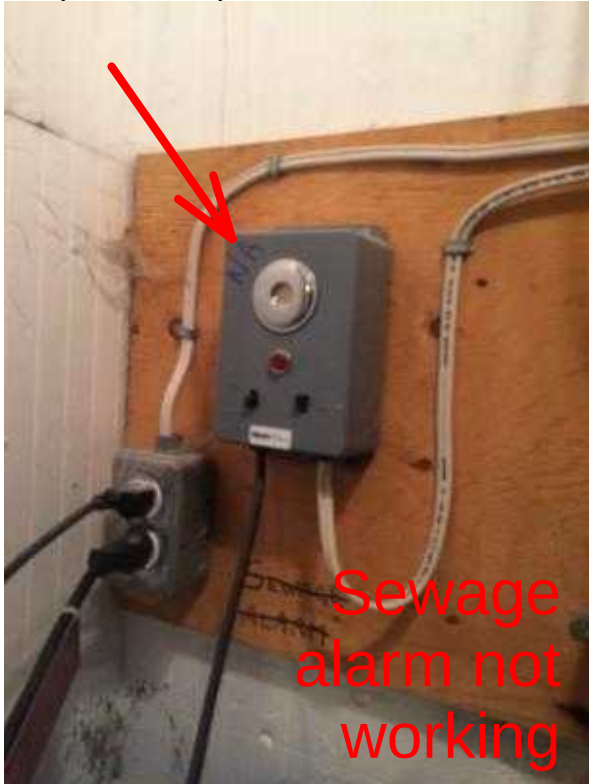
18. Drains: ABS Pump not working

transfer pump not working, outlet kept tripping, furnace is on same circuit and outlet is not GFCI protected or covered

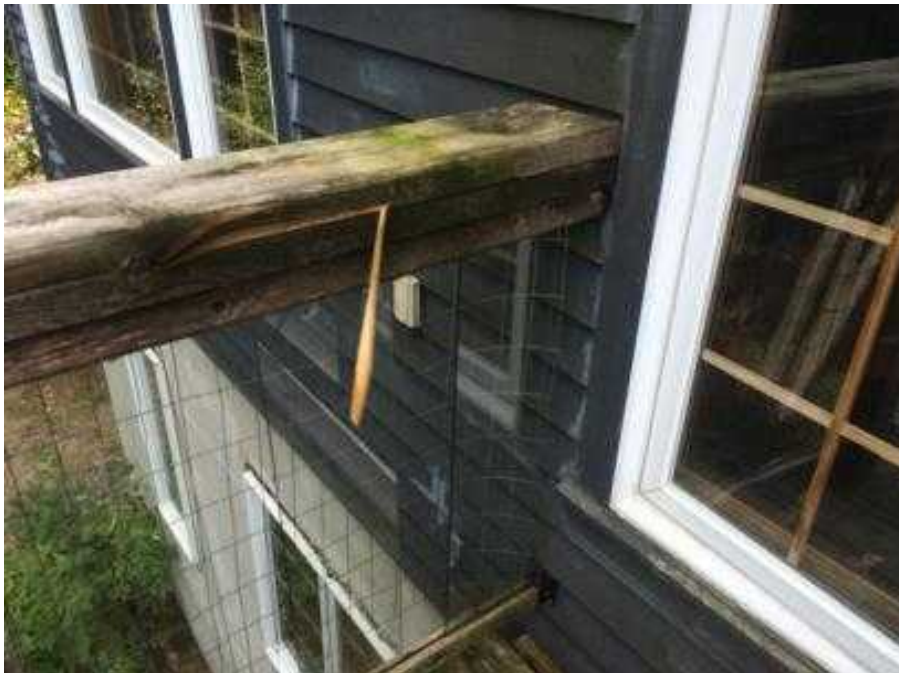
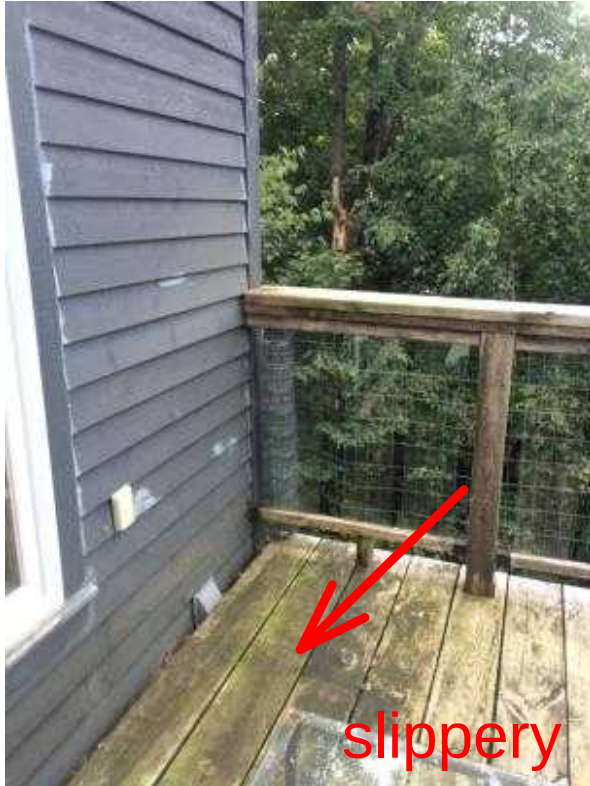
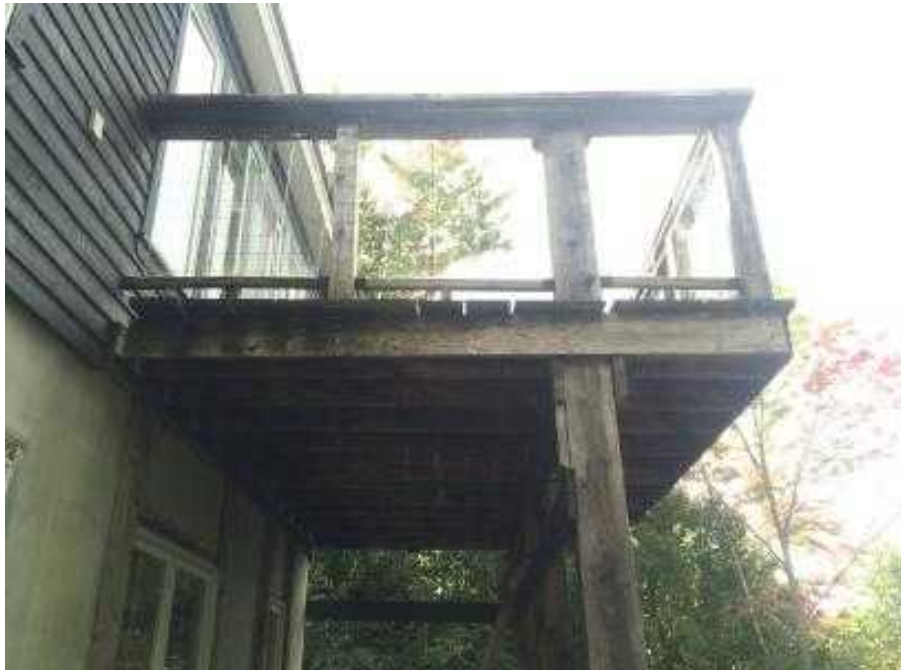
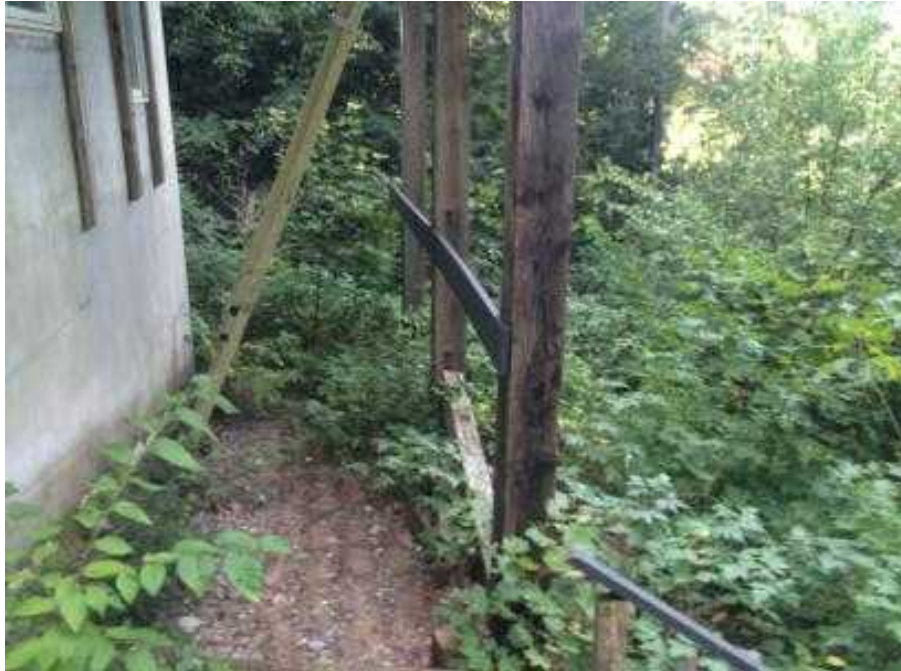
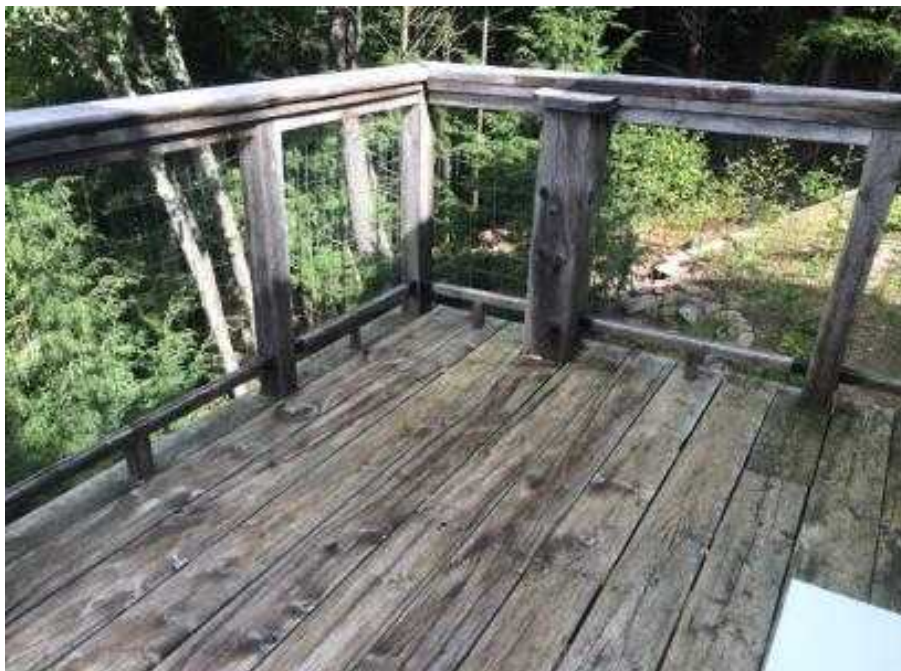
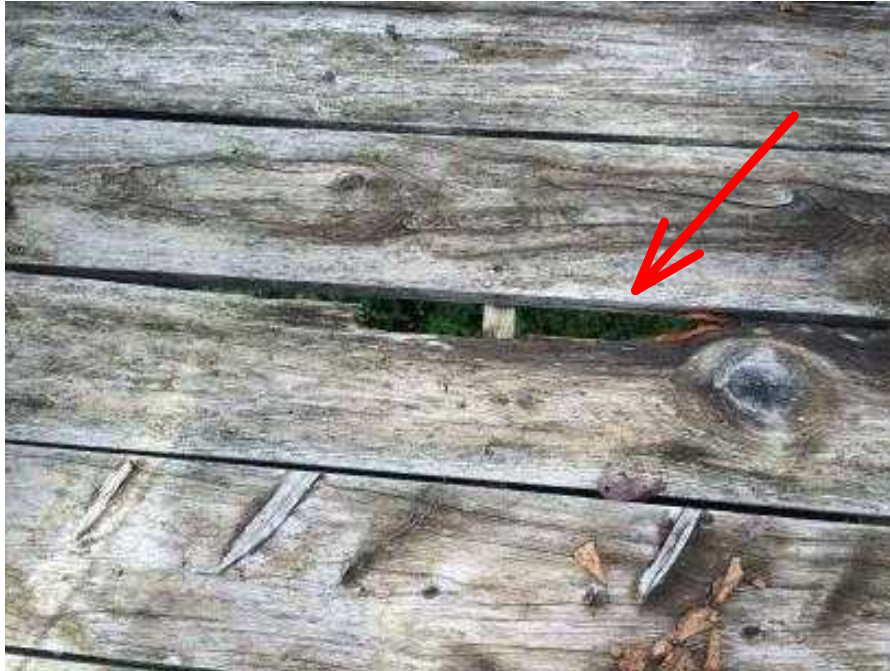
Deck: Untreated wood older wood, not built to current standards, does not appear to be properly supported maintenance and repair needed, falling hazard, ongoing monitoring for wood and railing stability will be needed, monitor snow load and shovel as needed

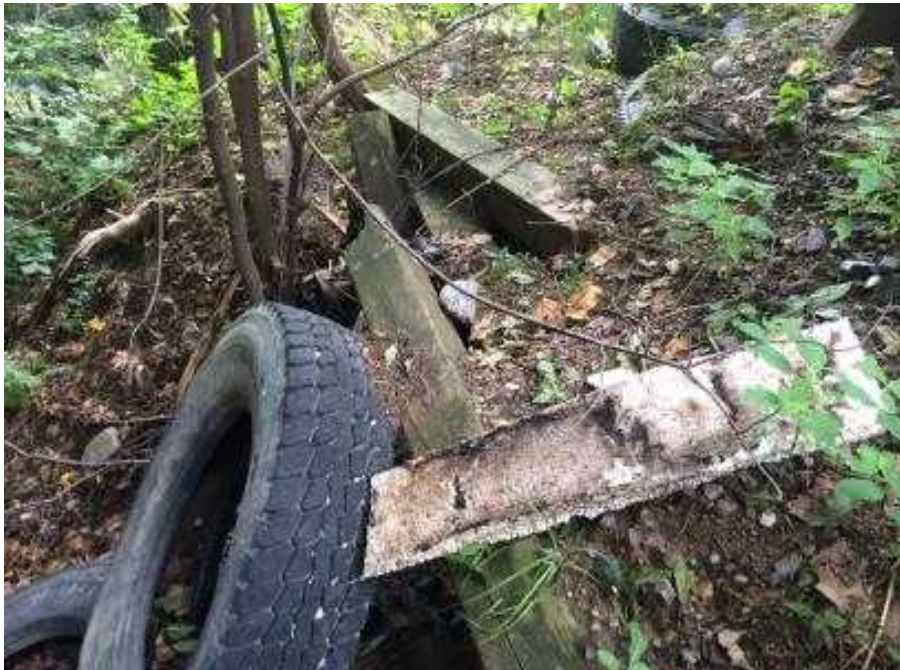
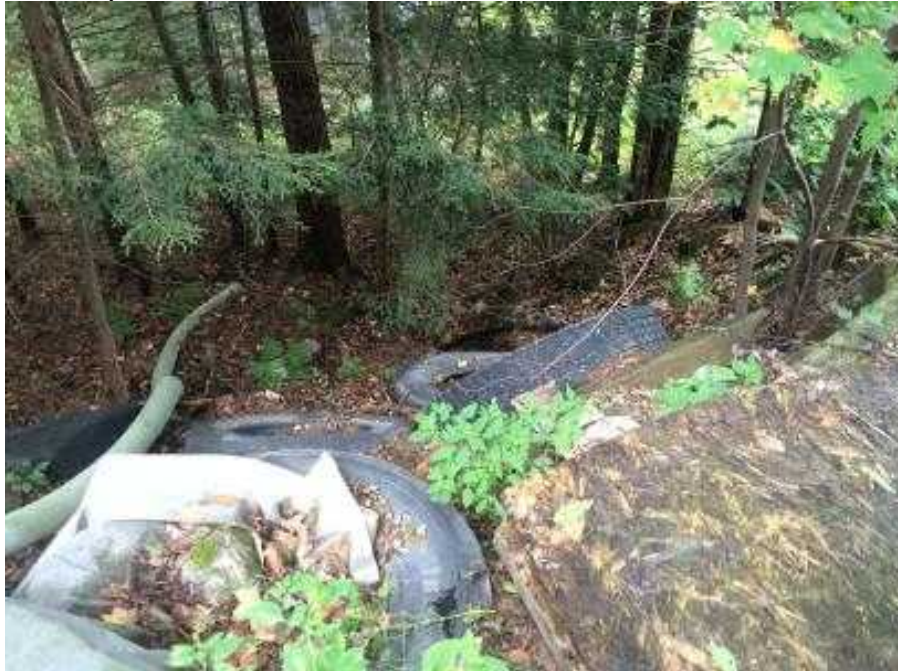
Retaining Walls: Rocks and old tires retaining walls are falling apart, suggest repairing the walls, ongoing monitoring and early correction of any issues to prevent a bigger problem

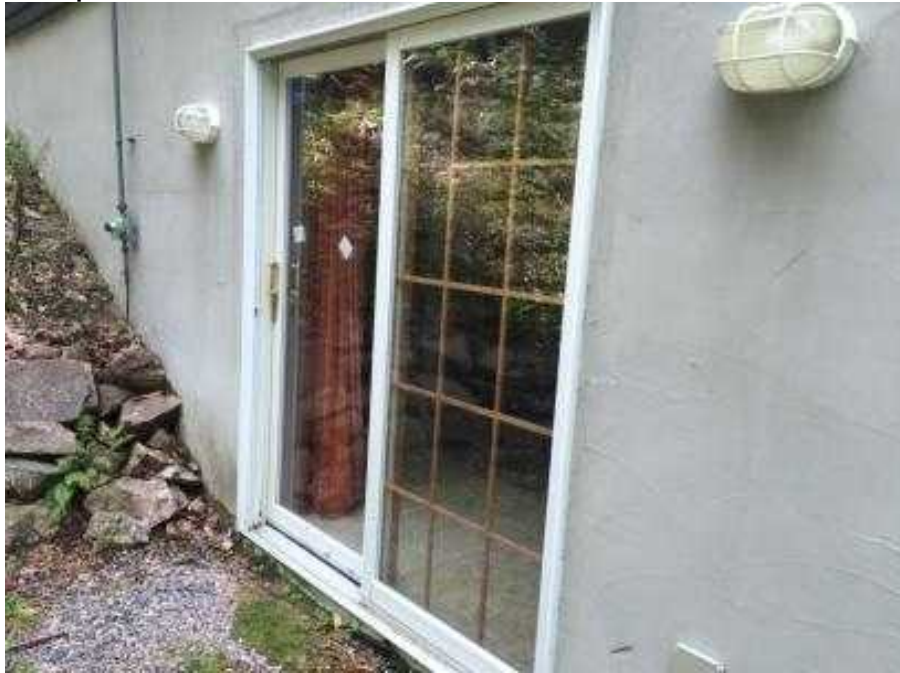
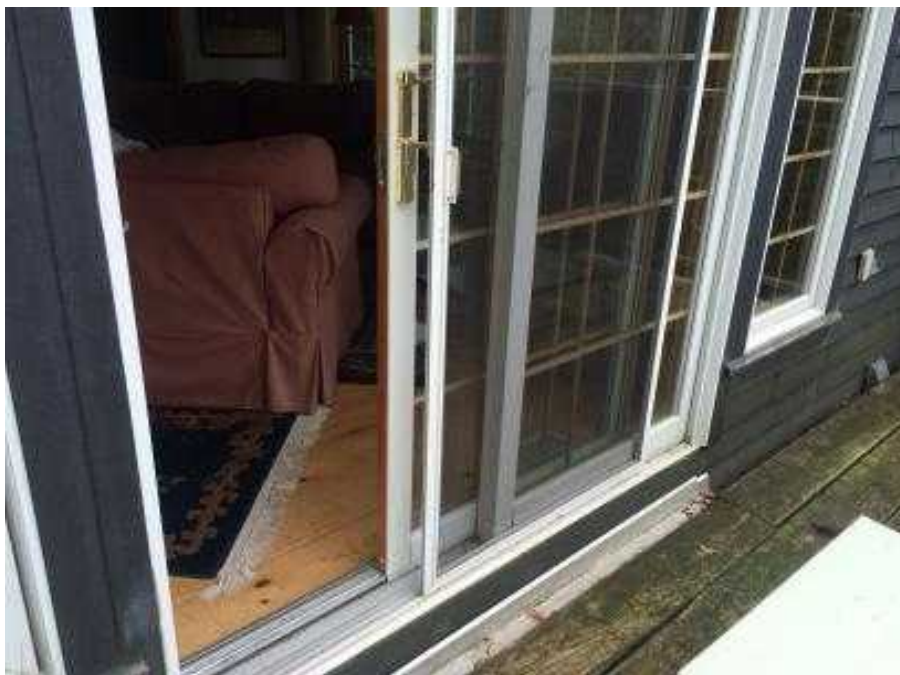
Patio Door: Vinyl sliding there is no screen for this door, exterior light did work at time of inspection

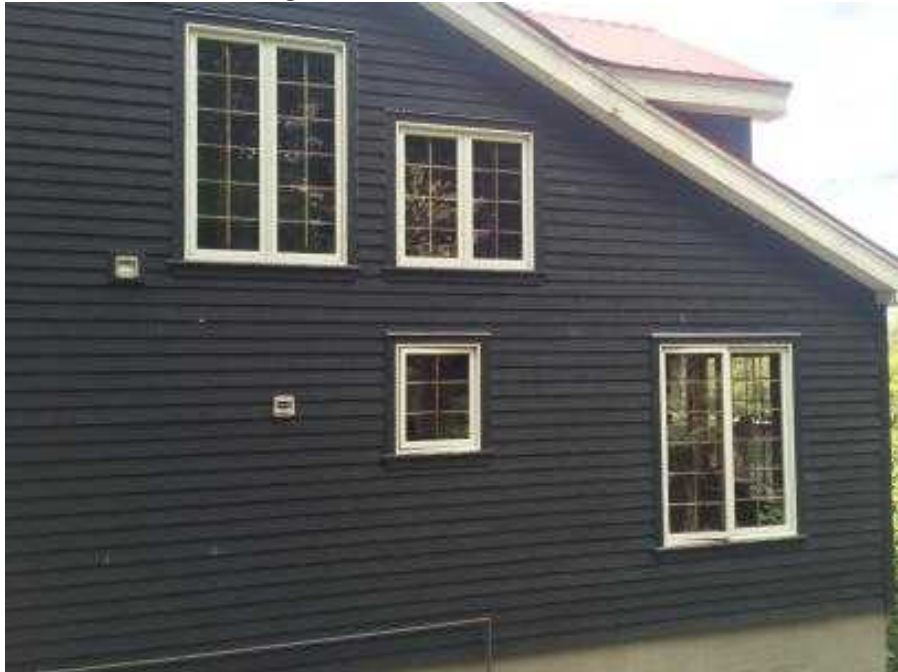
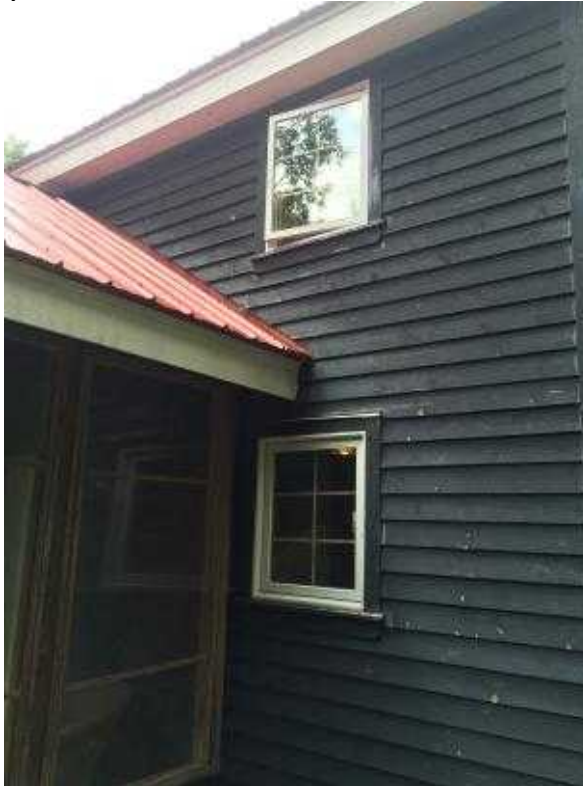
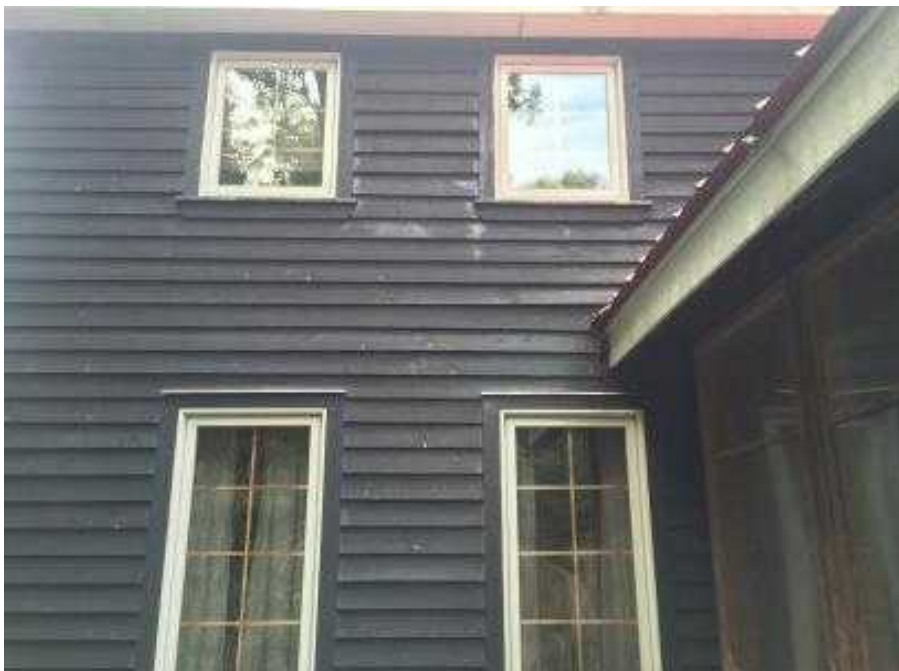
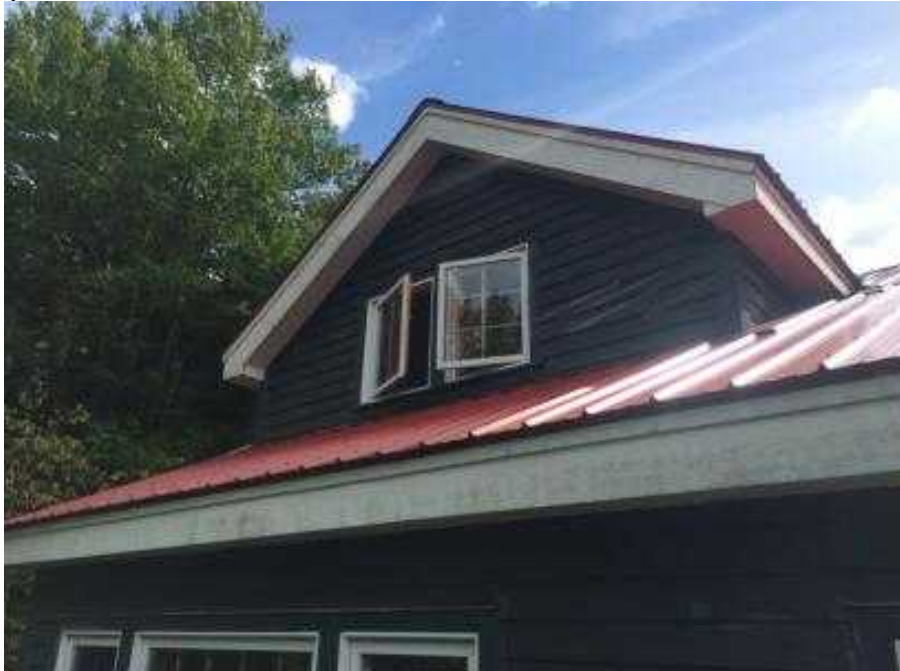
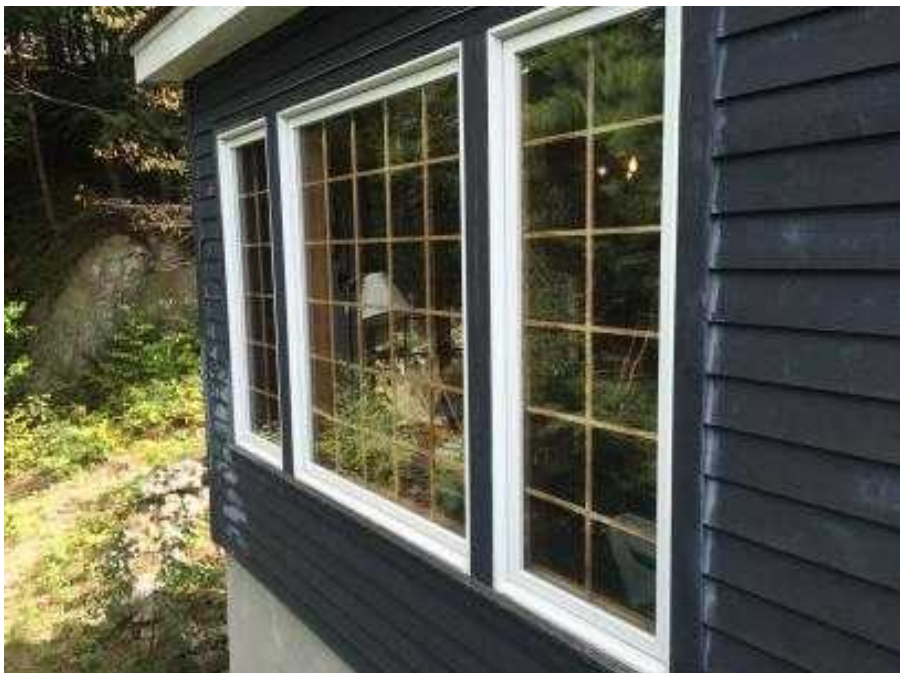
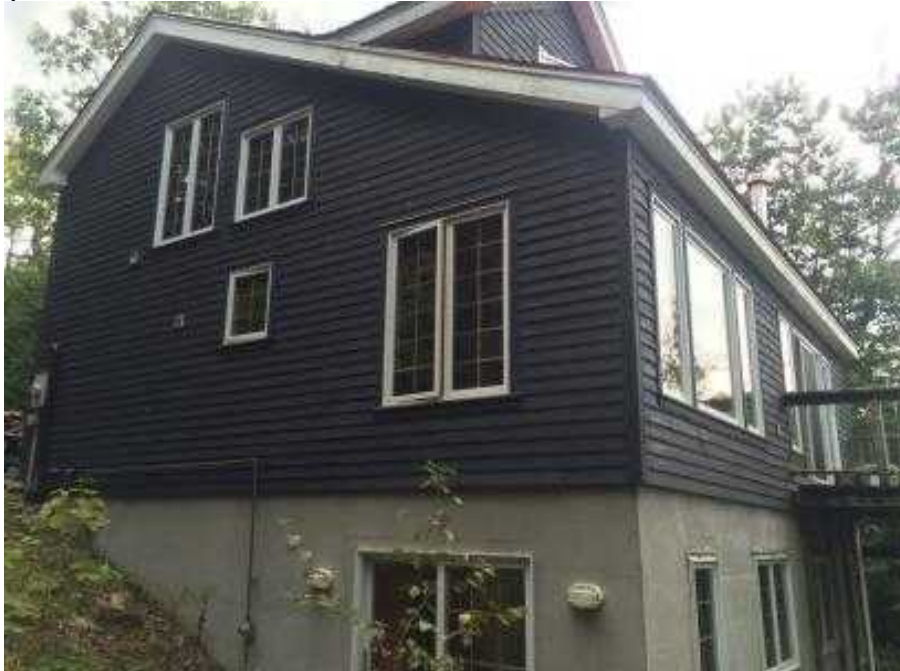
Windows: wood casement windows exterior window wood in need of maintenance in places, parts of the windows that open out have wood damage and are in need of maintenance, rust on some of the casement hinges

The wood exterior was in decent shape. Some maintenance is required in places and ongoing maintenance will be needed. Maintaining the integrity of the siding, soffit and fascia will help prevent water, rodent and bug entry into the home. The basement windows are not finished and should be finished to prevent water, rodent or bugs from getting behind and causing damage. The windows are non opening and wood casement. The exterior wood requires maintenance and repair in places. The wood casement windows all opened and closed. Water staining is present on the window ledges. The wood windows had old moisture damage and the hinge mechanisms had some rust and water damage. Maintenance and repair will be needed.
