# Clearview Home Inspection

Prepared for: R Wight

Prepared by: Clearview Home Inspection  
21 Worsley Lane  
Nobel , Ontario P0G1G0  
HST # 84475 6890 RT0001

09:39 May 30, 2017

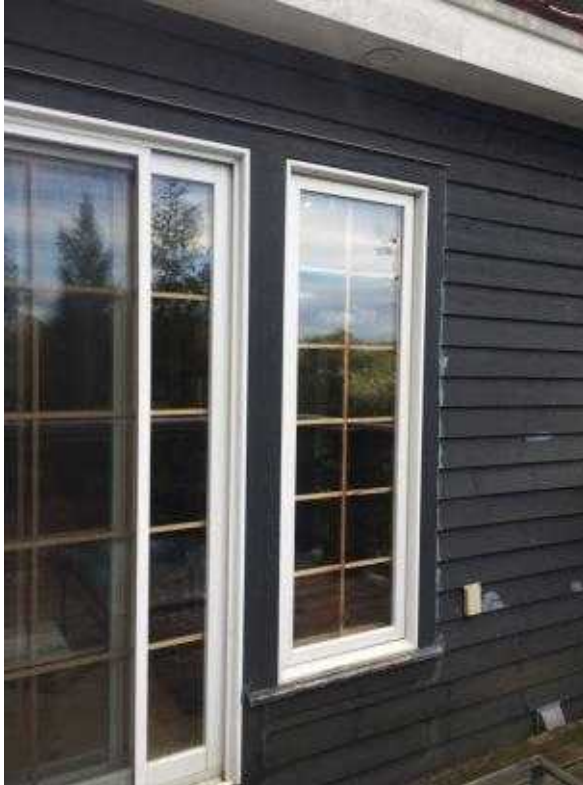
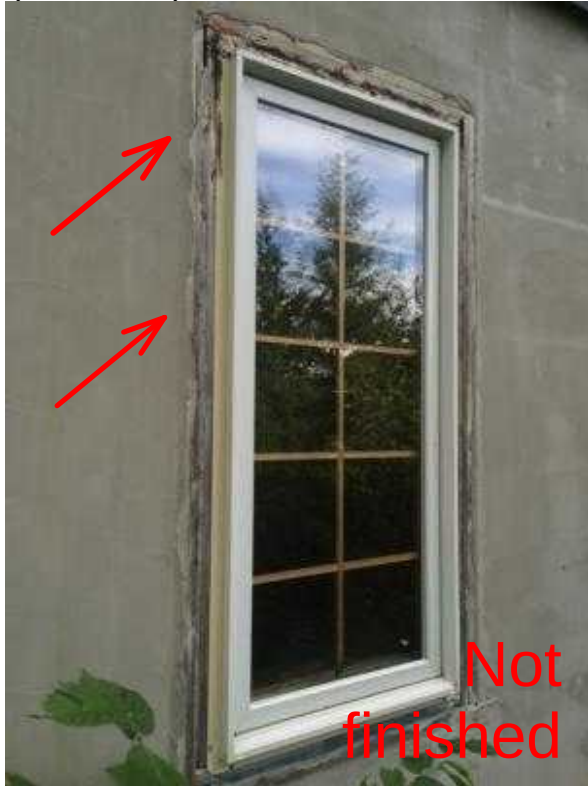
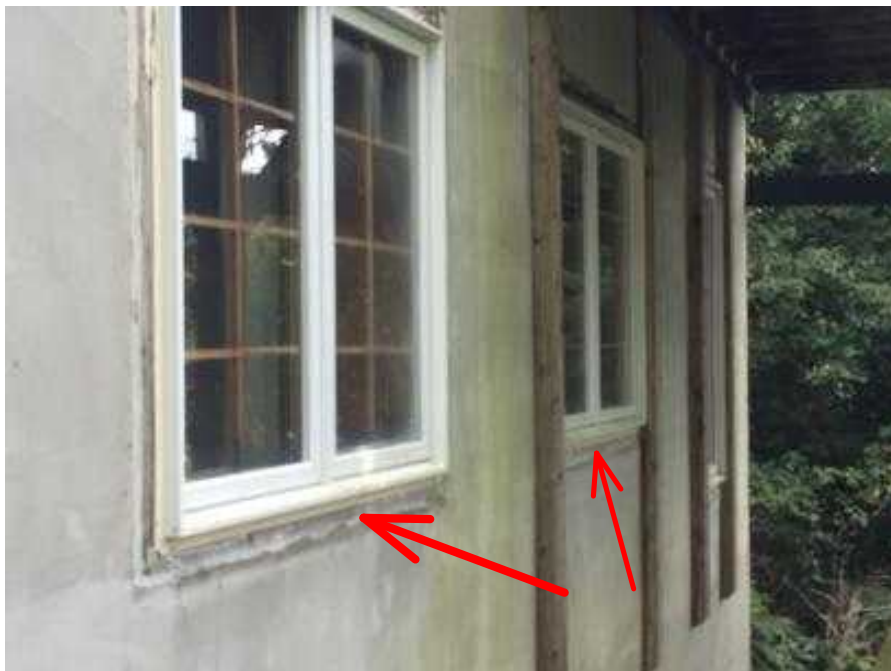
Basement Windows: Vinyl not finished and need to be finished as water, rodents and bugs will get behind and cause damage

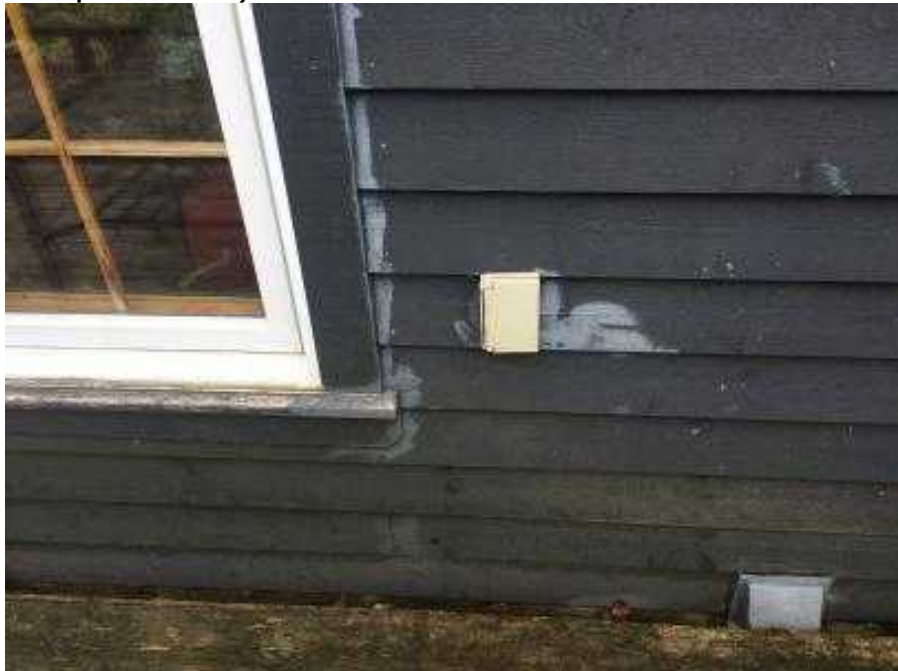
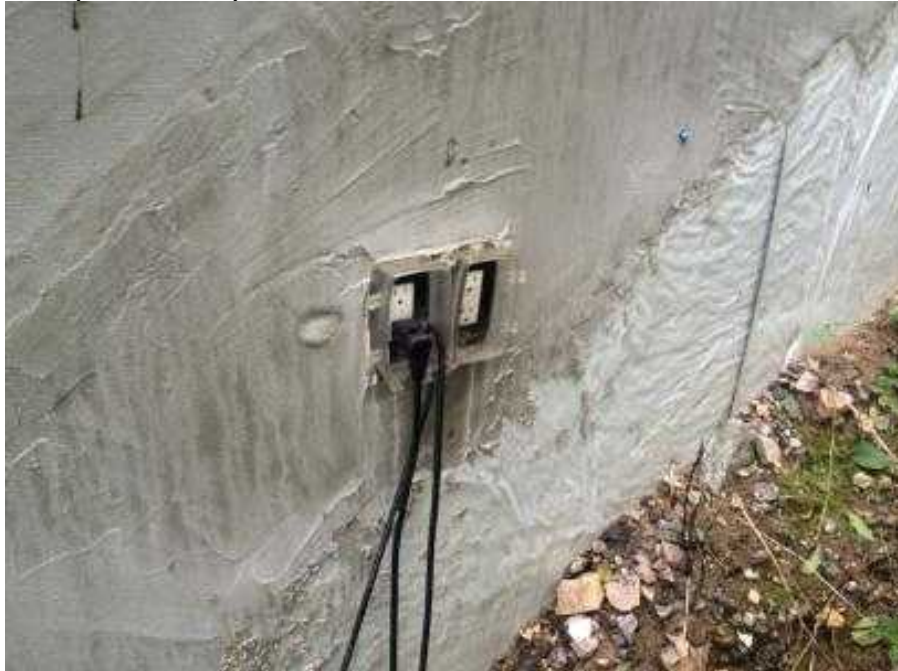
Exterior Electric Outlets: 110 VAC GFCI 5 exterior outlets were tested, two GFCI outlets were not tripping and will need replacement, two were not GFCI protected and should be as are exposed to water, one exterior outlet(that the transfer pump was plugged into) was on the same circuit as the furnace so when the pump tripped the breaker the furnace would not come on (discussed at time of inspection)

No issues were noted at the electric panel. There is an extension cord near the panel that is attached to a wiring circuit and this is not proper wiring. 5 exterior outlets were tested, two GFCI outlets were not tripping and will need replacement, two were not GFCI protected and should be as are exposed to water, one exterior outlet(that the transfer pump was plugged into) was on the same circuit as the furnace so when the pump tripped the breaker the furnace would not come on (discussed at time of inspection). The outlet that the washer was plugged into showed incorrect wiring. The outlets along the work bench were showing open ground when tested with the tester. There is some unfinished wiring which should be properly closed off. There is a light under the stairs in the wood shop which is improperly wired and wire is rubbing on

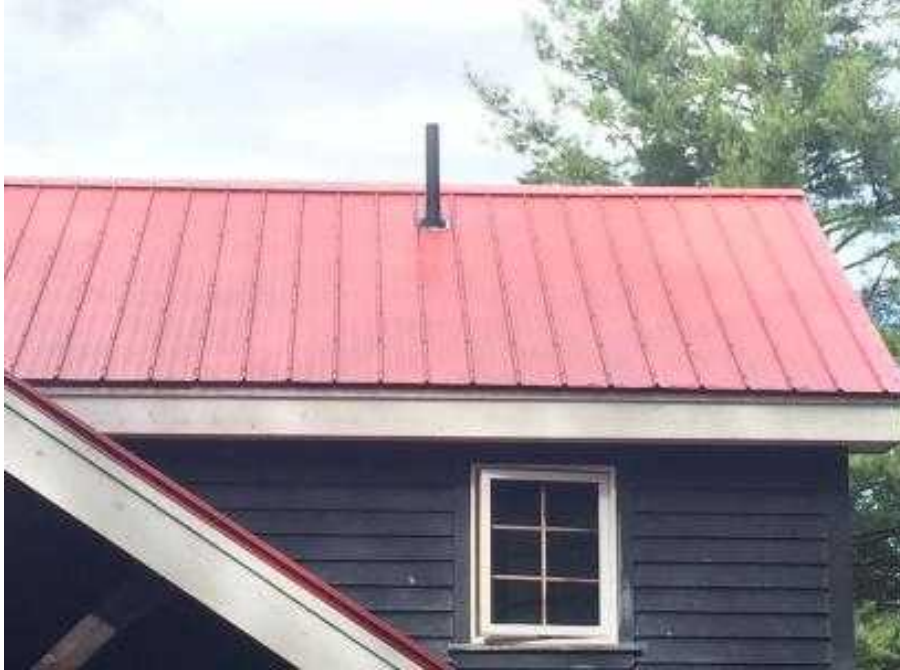
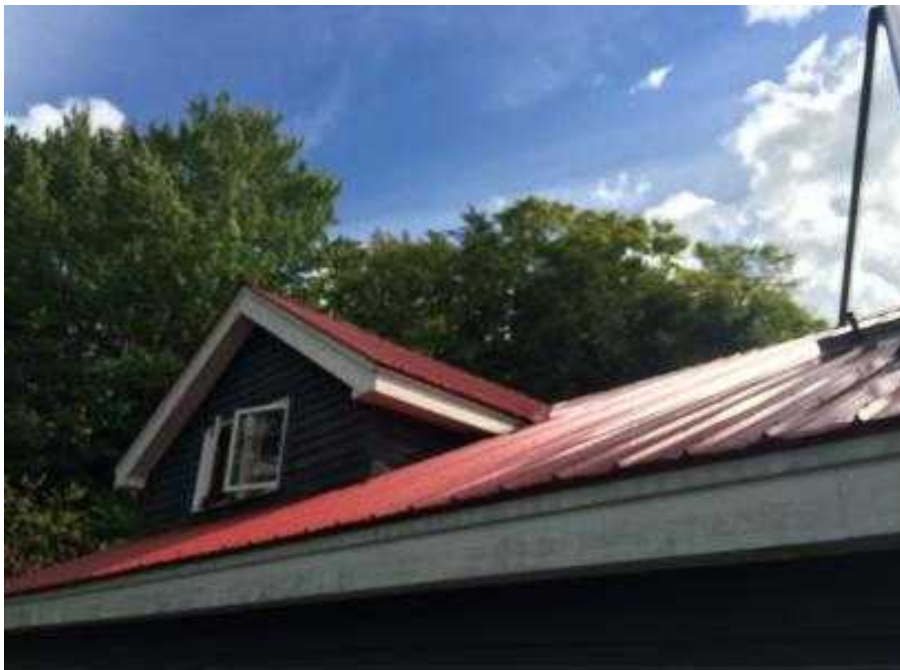
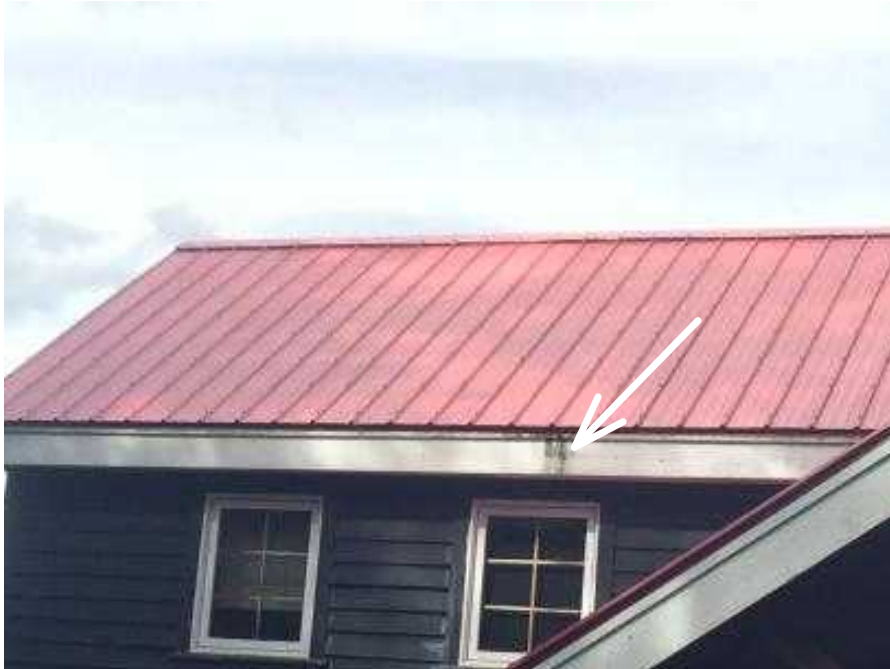
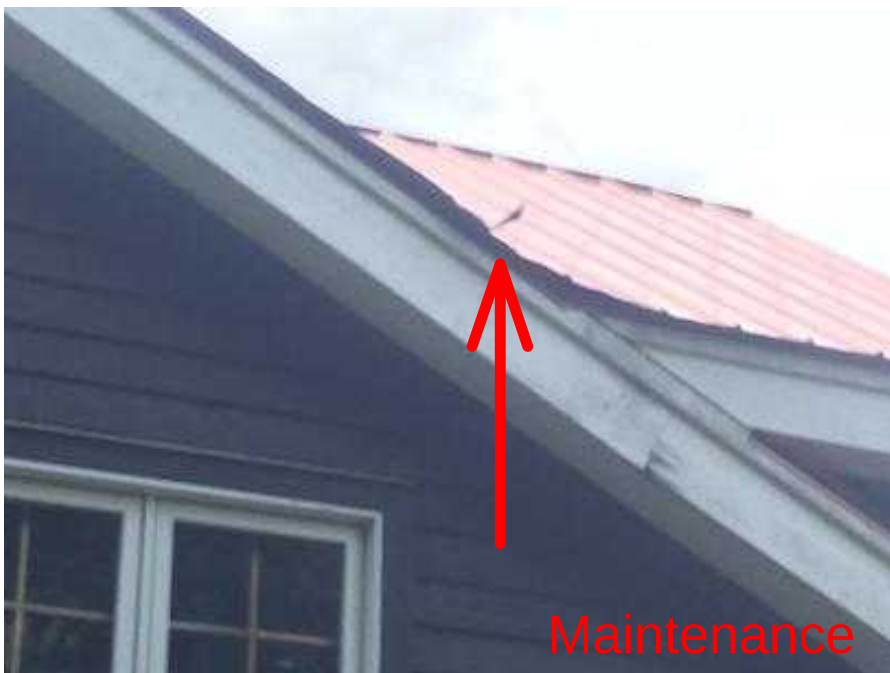
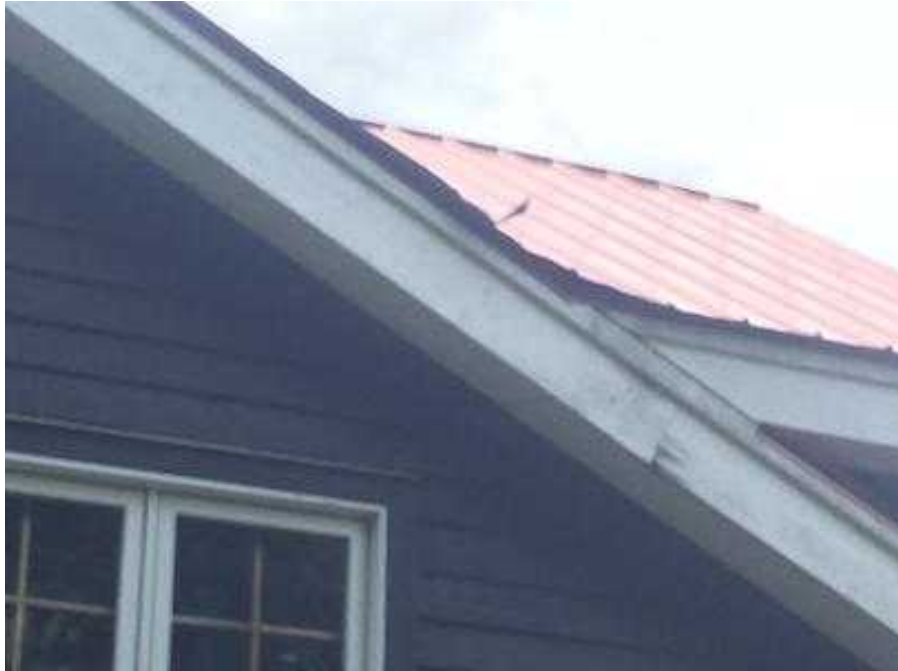
Material: Metal some damage noted in valley area (may be damaged from ice and snow), repairing damaged areas will help prevent moisture intrusion and help prolong the life of the roof

The cottage has a metal roof. Some minor damage noted. Assessing the roof on a regular basis and completion of any needed maintenance will help prolong the life of the roof. Assessing in the spring is a good idea in case there is any snow or ice damage. Snow and ice will come off a metal roof with enough velocity to cause damage to anything in it's path or cause injury should someone be in the way when the ice lets loose. There is no gutter system on this home. Roof drainage will splash around the foundation and lead to foundation damage and moisture intrusion into the basement area. As ground drainage is an issue you do not want to have roof drainage pooling near the foundation or deck footings. We suggest watching the roof drainage during a storm and if it is going to lead to damage of the home or erosion around it we suggest installing a gutter system especially for a metal roof. A good roof drainage system is comprised of gutters, downspouts and leader extensions. Lack of a proper roof drainage system in a home will lead to damage to the exterior and foundation. Water will pool around the foundation causing damage and possibly water intrusion. Gutters must be all

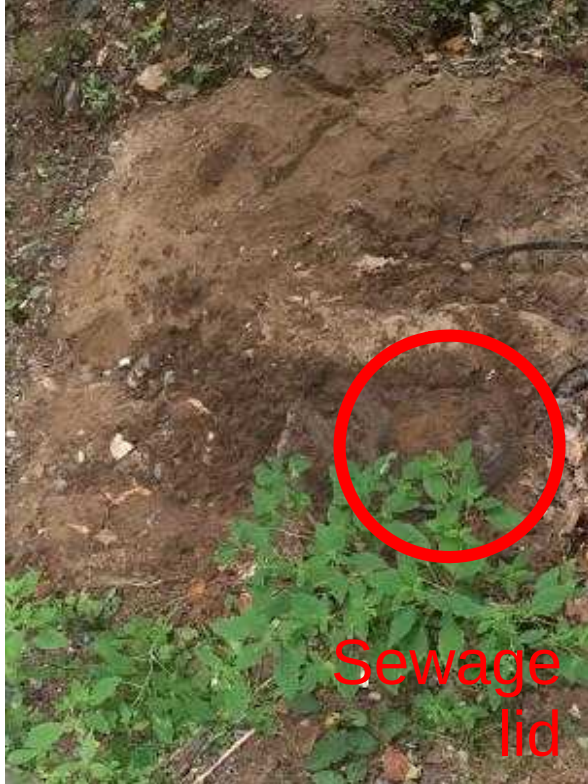
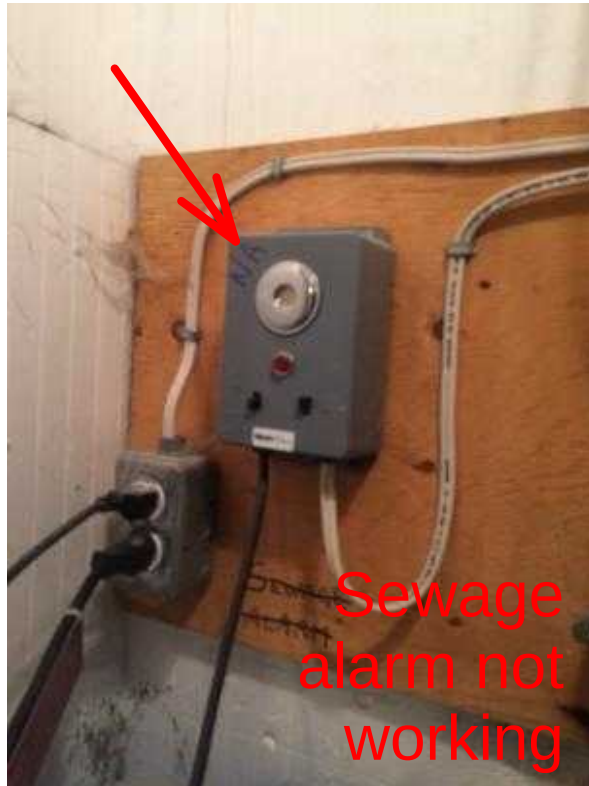
Drains: ABS Pump not working

transfer pump not working, outlet kept tripping, furnace is on same circuit and outlet is not GFCI protected or covered
