Clearview Home Inspection

101 Sample property
Emsdale, Ontario M5M1S8

Prepared for: Buyer

Marginal Summary

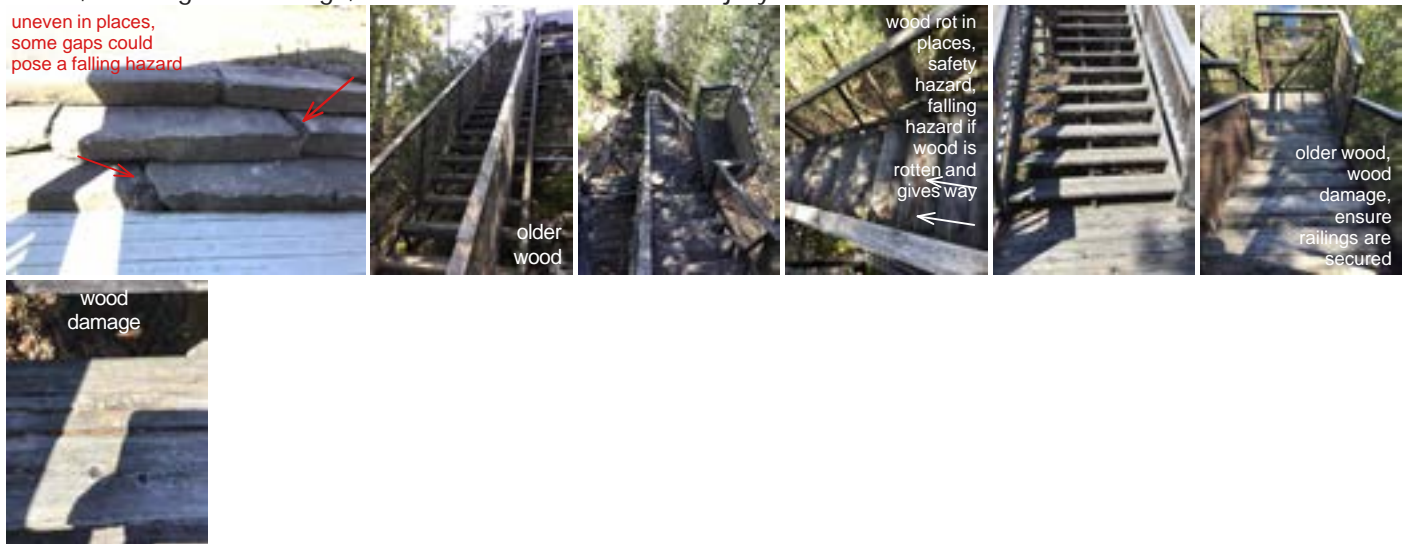
1. Steps/Stoops: see pictures - older wood, wood damage and wood rot, if railings are secured to damaged/rotten wood, the railings will not be secure, monitor all railings for safety, ongoing monitoring for safety will be needed for stairs, decking and railings, a fall could lead to serious injury

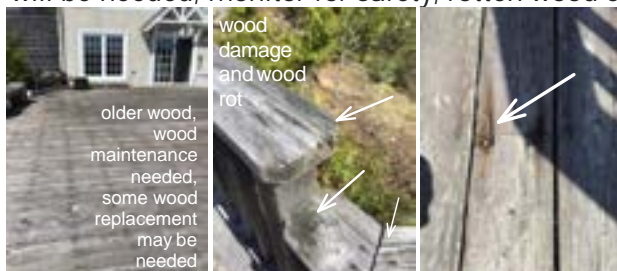
2. Patio: Wood - older wood, wood damage and wood rot, repair and maintenance and likely some wood replacement will be needed, monitor for safety, rotten wood can give way

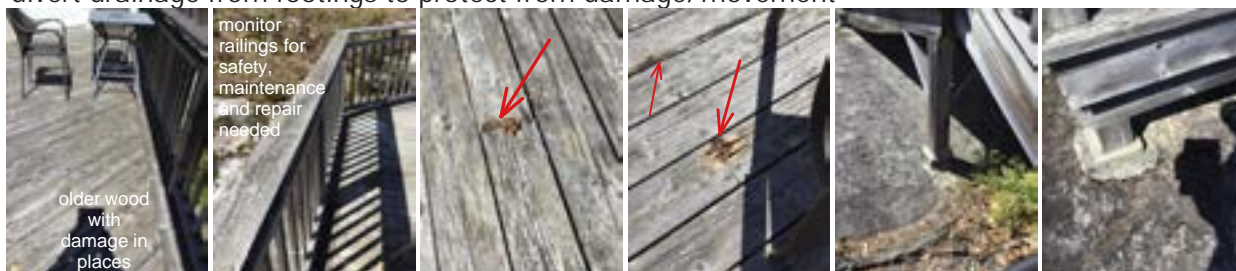
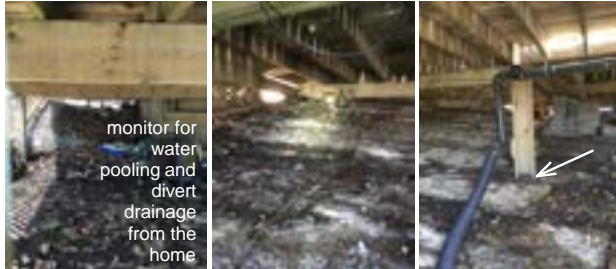
3. Deck: Untreated wood - older decking, appears to be original decking, not built to current standards, wood damage/wood rot noted, as discussed maintenance may help but appears repair and some wood replacement will be needed, wood and wood supports at ground level will need monitoring for moisture damage and movement, divert drainage from footings to protect from damage/movement

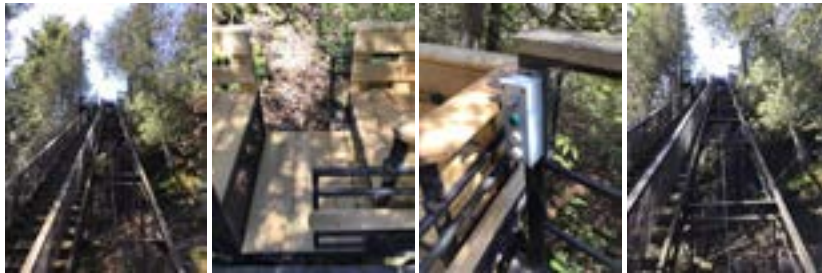
4. Lift to the boathouse: Rail system - the lift appears to be working as it should, only marked marginal to note the safety hazards, possible falling hazard if lift does not work properly, monitor children/pets on the lift as they could fall, get fingers/hands etc... caught in the machinery, regular inspection and maintenance is recommended to keep lift as safe as possible, keep lift locked so children do not use unsupervised

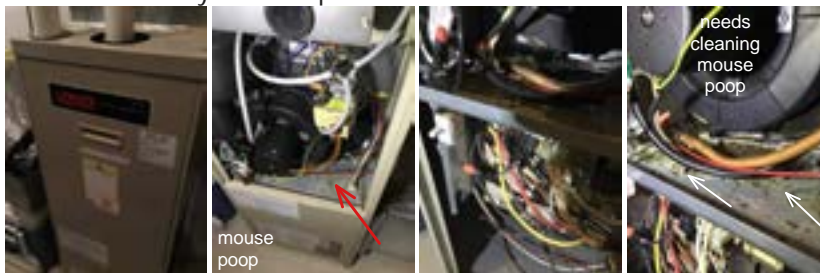
7. Main Heating System Heating System Operation: only marked marginal to note the furnace has rodent excrement in it and needs cleaning - older furnace at the end of it's life expectancy, the furnace should be serviced on a regular basis for optimal functioning as well any needed upgrades as regulations do change for heating systems, we recommend having the furnace and HRV serviced and maintenance done as needed, if you have a heating contractor out you may want him to service and clean the propane fireplace as well, getting it all done in one service call may be cheaper

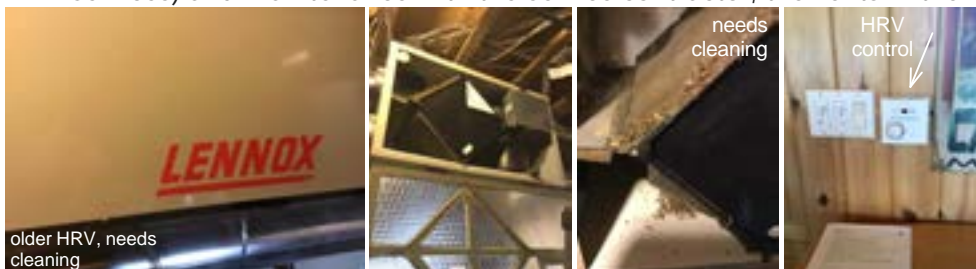
8. Main Heating System HRV: Lennox - HRV did come on but does not appear to be working properly, there are vents in rooms, timer controls which appear to be for the HRV no air movement was noted when the unit/timers were switched on, the unit needs cleaning and servicing to ensure the unit works, go over operation (and the areas the HRV services) and maintenance with the service contractor, the vents in the rooms may need cleaning

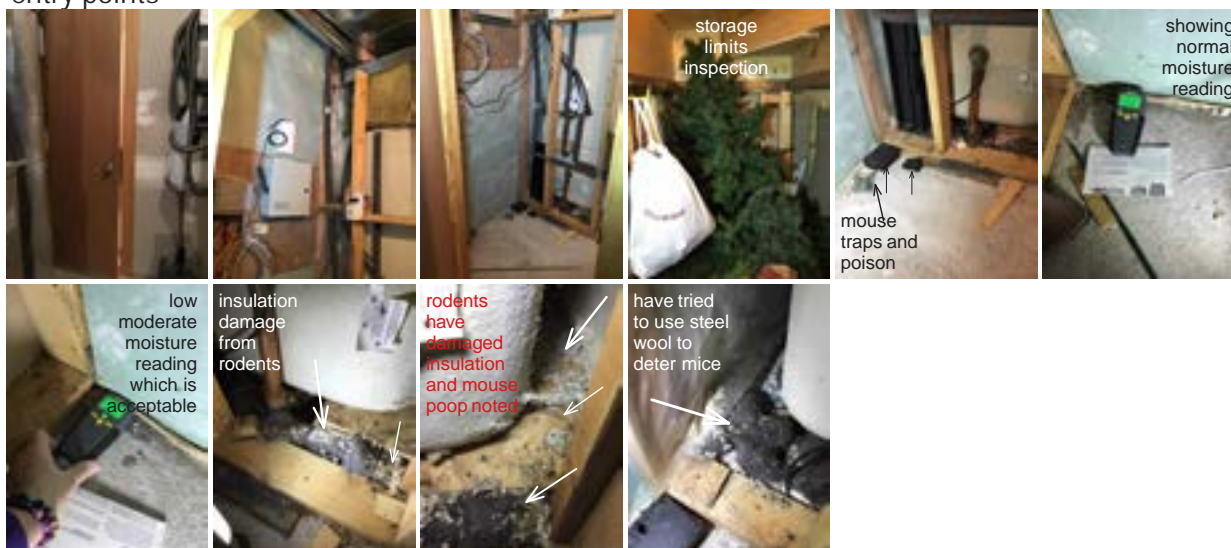
9. Utility Basement Storage room only marked marginal to note signs of rodent intrusion and insulation damage - mouse traps and mouse poison noted, if you have pets ensure the poison is cleaned up and watch for poison in other areas, some insulation damage as rodents have used insulation for nesting, assess for and secure any rodent entry points

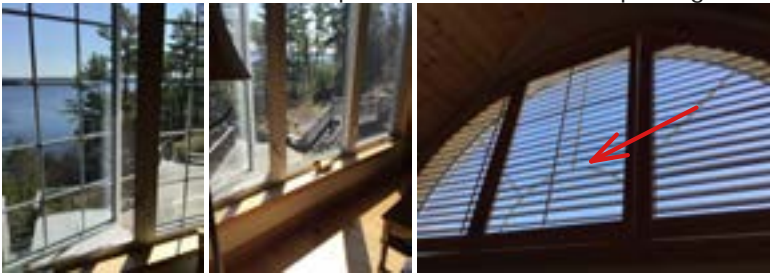
12. Main Living Space Windows: Vinyl casement - upper window has a broken seal, monitor and repair as needed, other windows were in acceptable condition and opening and closing

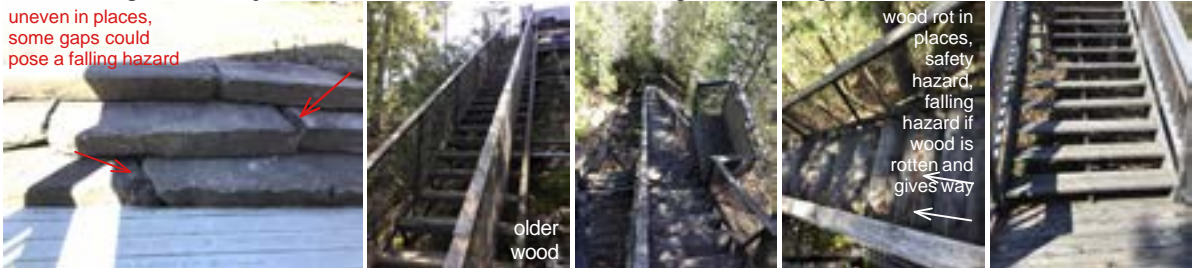
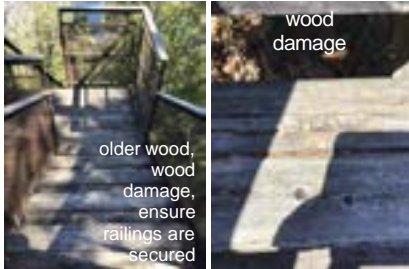
Steps/Stoops: see pictures - older wood, wood damage and wood rot, if railings are secured to damaged/rotten wood, the railings will not be secure, monitor all railings for safety, ongoing monitoring for safety will be needed for stairs, decking and railings, a fall could lead to serious injury

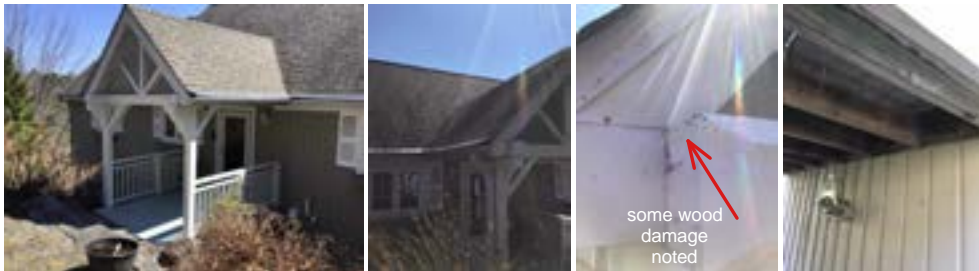
Porch: Wood - Some wood rot noted

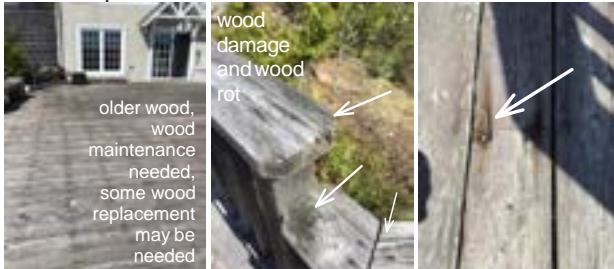
Patio: Wood - older wood, wood damage and wood rot, repair and maintenance and likely some wood replacement will be needed, monitor for safety, rotten wood can give way

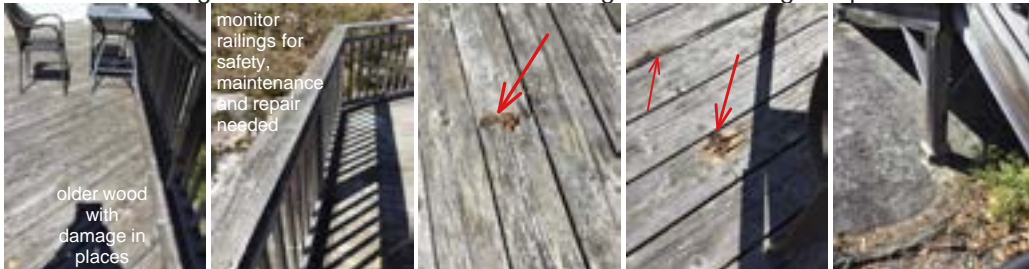
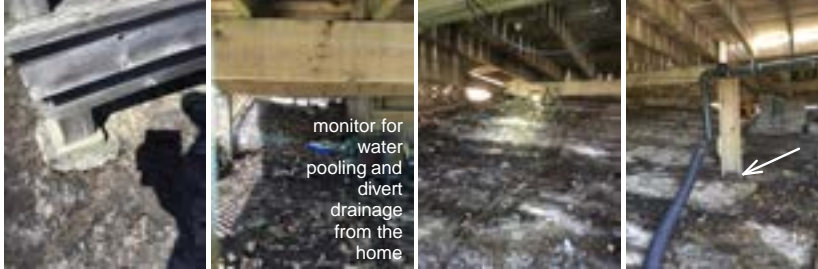
Deck: Untreated wood - older decking, appears to be original decking, not built to current standards, wood damage/wood rot noted, as discussed maintenance may help but appears repair and some wood replacement will be needed, wood and wood supports at ground level will need monitoring for moisture damage and movement, divert drainage from footings to protect from damage/movement

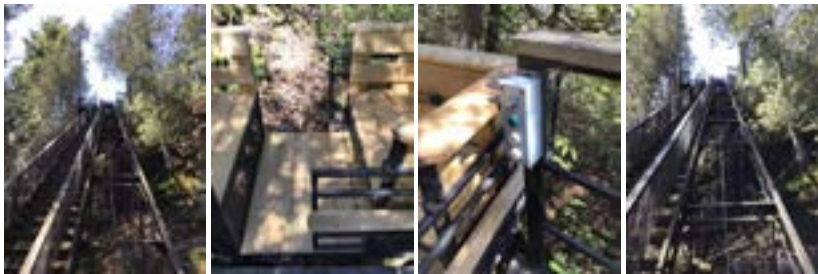
Lift to the boathouse: Rail system - the lift appears to be working as it should, only marked marginal to note the safety hazards, possible falling hazard if lift does not work properly, monitor children/pets on the lift as they could fall, get fingers/hands etc... caught in the machinery, regular inspection and maintenance is recommended to keep lift as safe as possible, keep lift locked so children do not use unsupervised

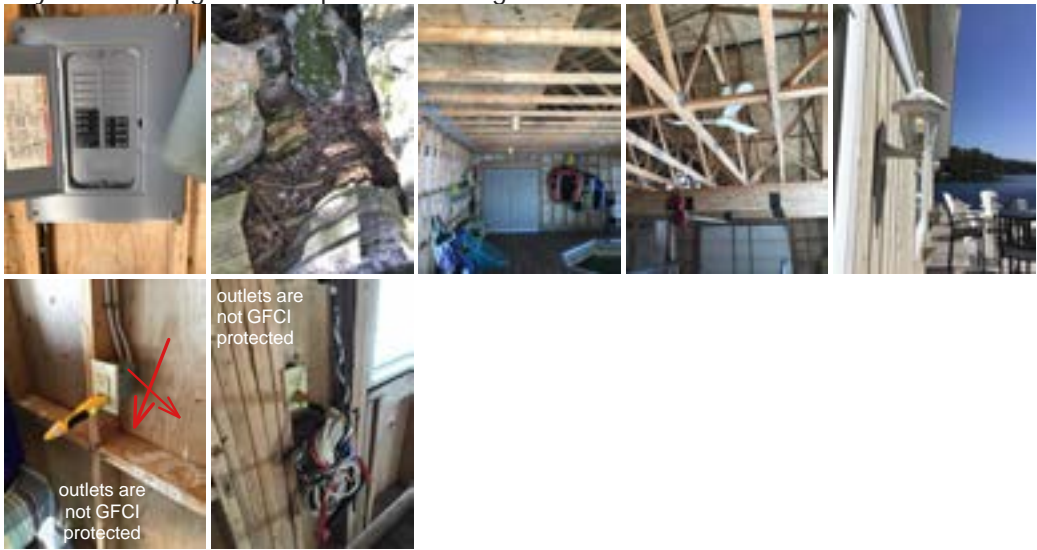
9. Marginal Electrical: 110 VAC - outlets are not GFCI protected, as electrical components are near water GFCI protection should be in place, have an electrician assess the wiring to the boathouse for safety and any needed upgrades as per current regulations

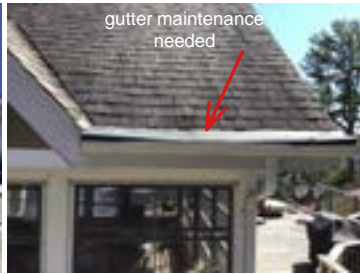
9. Acceptable Gutter System: Aluminum - some damage noted to gutter system and gutters may need cleaning, maintenance needed, ensure gutter system is draining roof drainage away from the home and is not pooling around the foundation

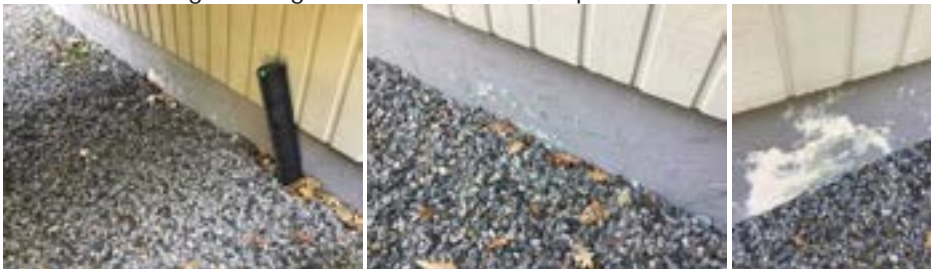
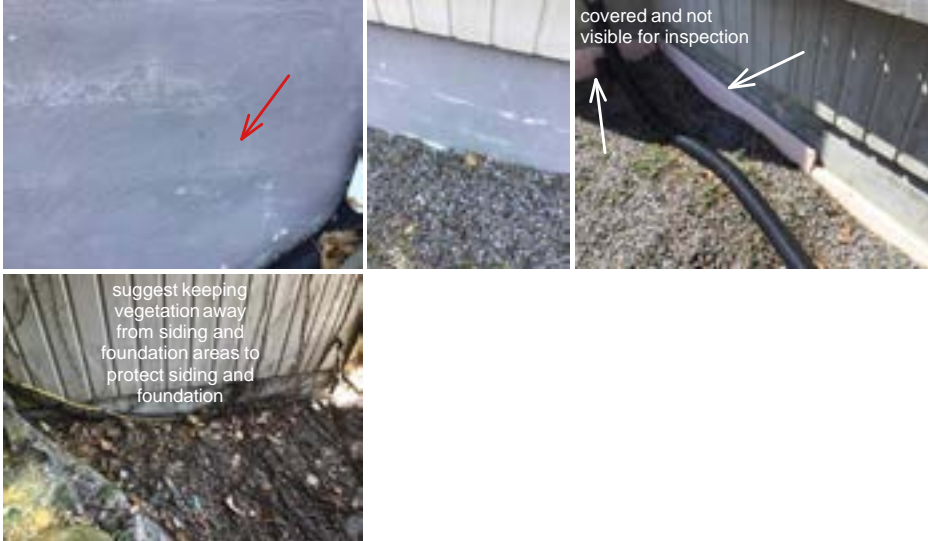
3. Acceptable Differential Movement: Minor cracking, Settling - monitor any cracking or areas of damage to ensure cracking/damage does not worsen, repair as needed

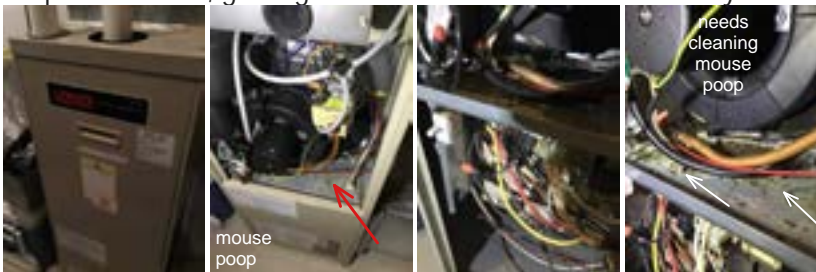
1. Marginal Heating System Operation: only marked marginal to note the furnace has rodent excrement in it and needs cleaning - older furnace at the end of it's life expectancy, the furnace should be serviced on a regular basis for optimal functioning as well any needed upgrades as regulations do change for heating systems, we recommend having the furnace and HRV serviced and maintenance done as needed, if you have a heating contractor out you may want him to service and clean the propane fireplace as well, getting it all done in one service call may be cheaper

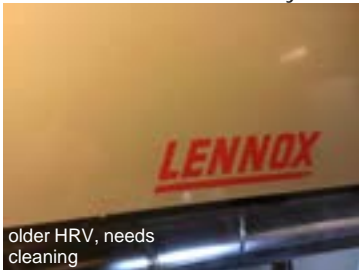
HRV: Lennox - HRV did come on but does not appear to be working properly, there are vents in rooms, timer controls which appear to be for the HRV no air movement was noted when the unit/timers were switched on, the unit needs cleaning and servicing to ensure the unit works, go over operation (and the areas the HRV services) and maintenance with the service contractor, the vents in the rooms may need cleaning

older HRV, needs cleaning

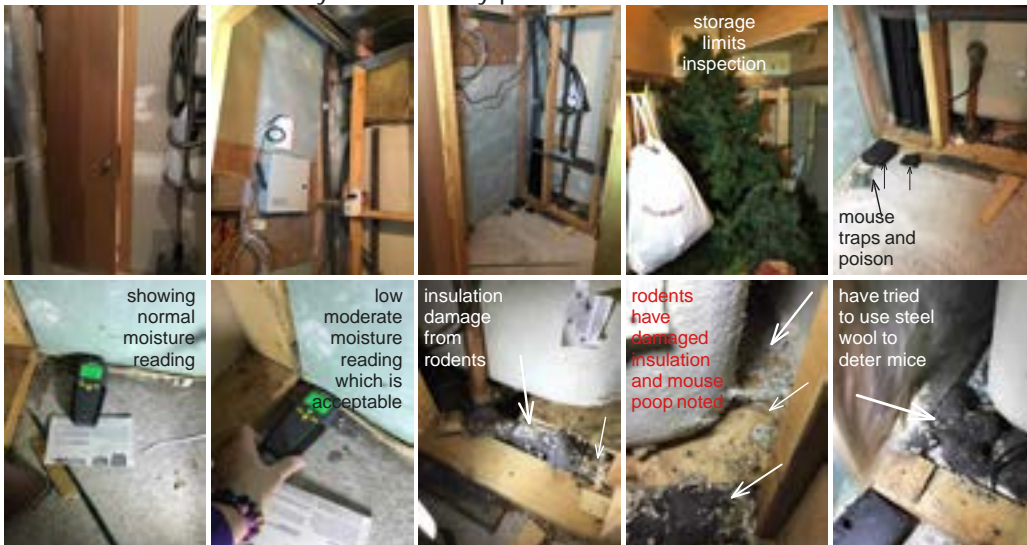
1. Marginal Storage room only marked marginal to note signs of rodent intrusion and insulation damage - mouse traps and mouse poison noted, if you have pets ensure the poison is cleaned up and watch for poison in other areas, some insulation damage as rodents have used insulation for nesting, assess for and secure any rodent entry points

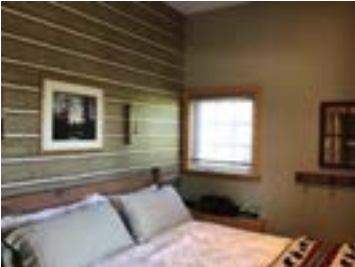
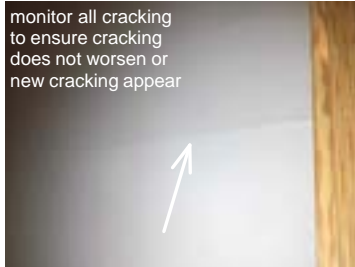
monitor all cracking
to ensure cracking
does not worsen or
new cracking appear

minor
cracking

cosmetic
damage

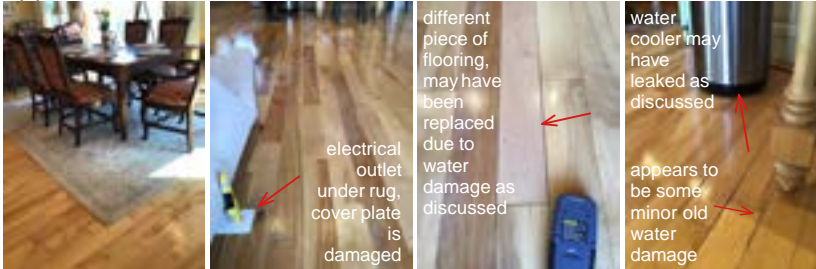
11. Acceptable Floor: Manufactured flooring and area rug - some old ceiling damage is noted in the living area in basement (under this area), there could have been a leak as discussed as a piece of flooring has been replaced, the owner may be able to offer insight as to what caused the damage, damage appears old, monitor

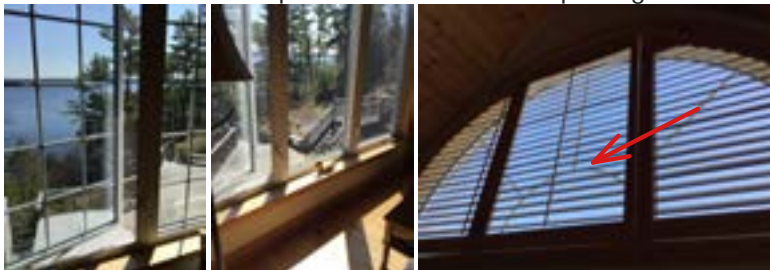
Windows: Vinyl casement - upper window has a broken seal, monitor and repair as needed, other windows were in acceptable condition and opening and closing
