Clearview Home Inspection

7 Carson Lane
Magnetawan, Ontario P0A1P0

Prepared for: Buyer

11:38 February 14, 2022

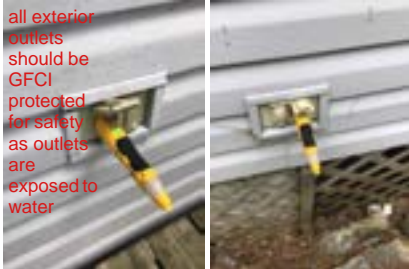
4. Exterior Electric Outlets: 110 VAC - all exterior outlets should be covered and GFCI protected for safety as they are exposed to water

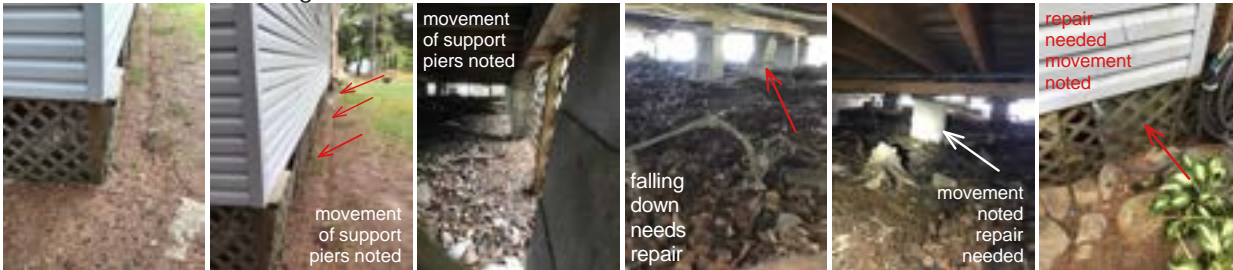
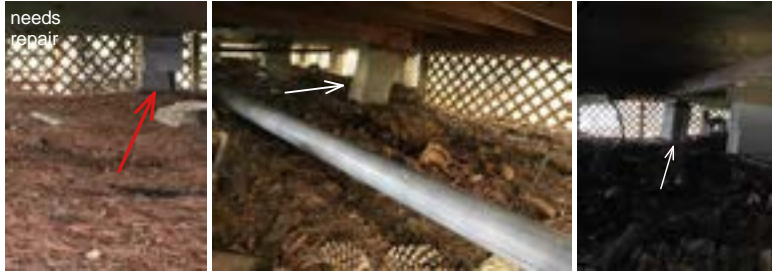
6. Differential Movement: Minor cracking, Settling, erosion - most supports are showing movement, some have more need of repair than others, you stated that you consistently over the years have had to repair the supports as they move around, the longer you leave the repairs the more chance for further movement and damage to the building, when you do your renovations discuss with the contractor better drainage management options as diverting as much roof and ground drainage from the foundation, supports or under the building will help protect the cottage from movement/damage,

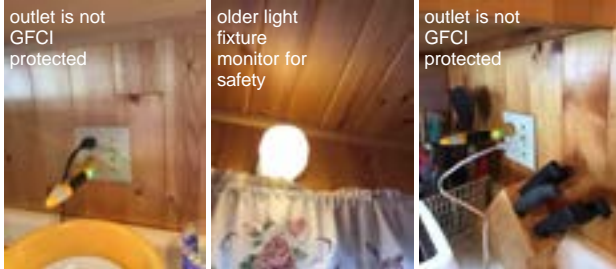
10. Main Kitchen Electrical: 110 VAC - outlets are not GFCI protected near the sink take care if using appliances plugged into outlets near the sink as there is no GFCI protection at outlets

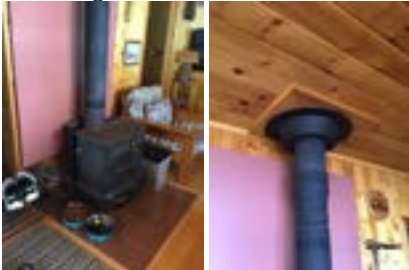
11. Main Living Space HVAC Source: as discussed wood stove does not meet WETT safety standards - we recommend not using the wood stove in it's current condition

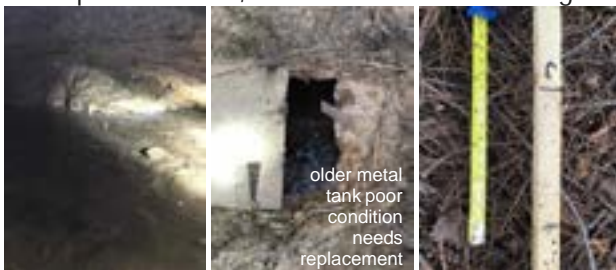
13. Method of Inspection: Flow test - 5 inch increase after 18 min, the flow test had to be stopped as the sewage level was rising too quickly and was close to overflowing, the drainage is not draining to the septic bed (if there is even a drainage bed we cannot confirm the presence of a septic bed), using the water/toilet too often will lead to back up or overflow, we recommend not using the washing machine as the drainage could cause overflow

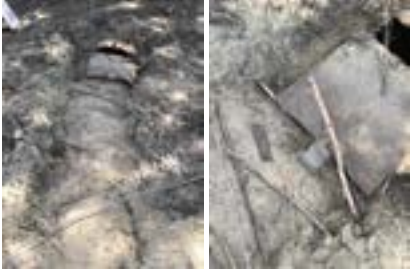
14. Tank: Metal - older metal tank well past it's life expectancy, tank may have damage and sewage could be leaking into the ground, the condition of the tank was discussed, the tank needs replacement, taking good care of the septic may help you get some more time out of it,

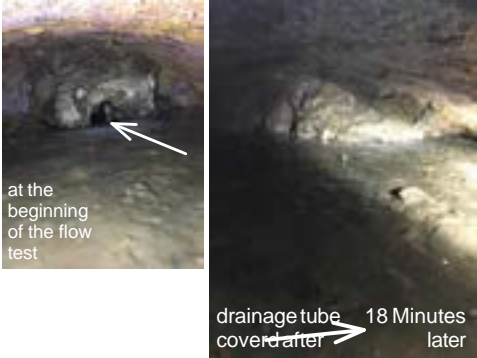
15. Baffles: None - there are no baffles and hard waste will be getting out to the drainage bed and plugging the tube/drainage bed, this can lead to back up or overflow, the septic tank needs replacement

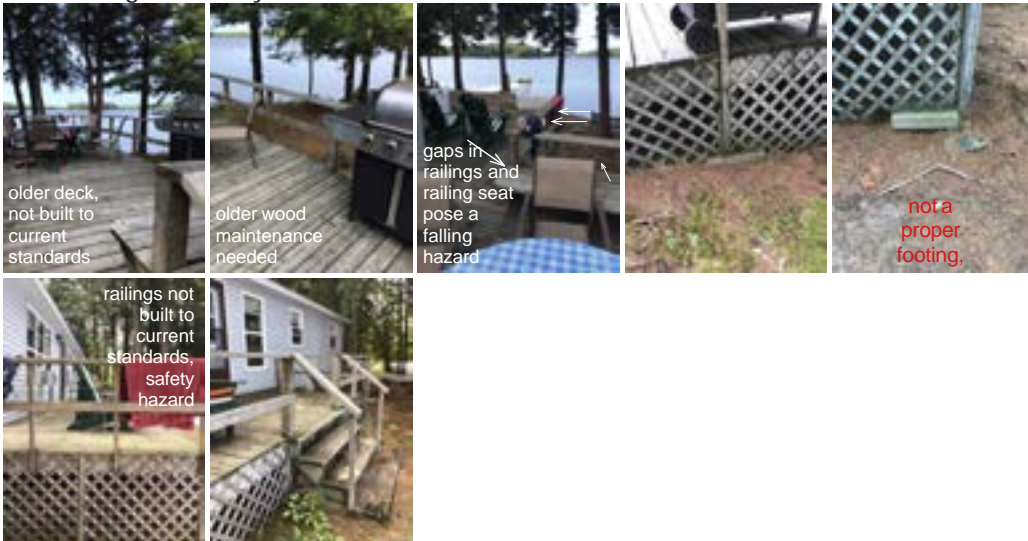
2. Marginal Steps/Stoops: Wood - older wooden steps, not built to current standards, movement noted, ongoing monitoring for damage and movement will be needed to ensure the stairs remain safe to use

3. Marginal Deck: Untreated wood - deck is older wood, some wood damage noted, repair/maintenance needed, not built to current standards, will be susceptible to movement from frost and drainage, railings pose a falling hazard as children or pets can fall through gaps or off the railing seat, ongoing monitoring for safety will be needed

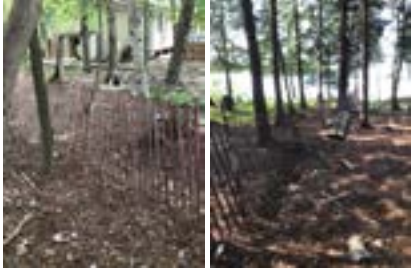
6. Marginal Fences: Wood - older fencing, poor condition, repair/replacement needed

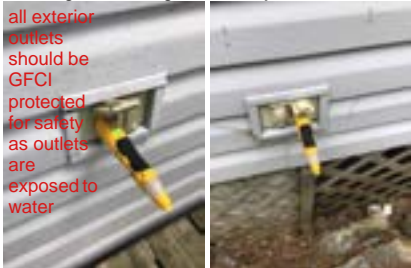
Exterior Electric Outlets: 110 VAC - all exterior outlets should be covered and GFCI protected for safety as they are exposed to water

all exterior outlets should be GFCI protected for safety as outlets are exposed to water

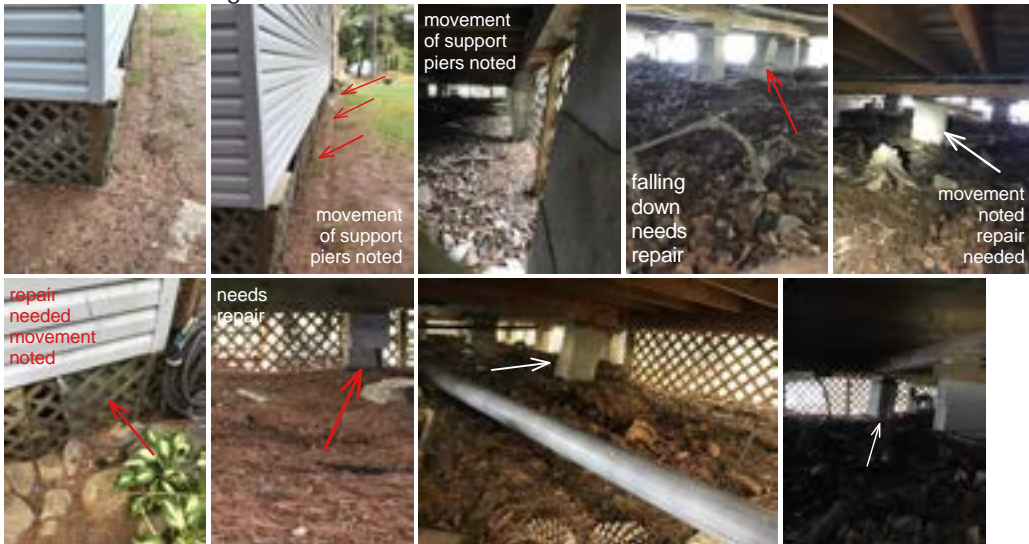
3. Marginal Differential Movement: Minor cracking, Settling, erosion - most supports are showing movement, some have more need of repair than others, you stated that you consistently over the years have had to repair the supports as they move around, the longer you leave the repairs the more chance for further movement and damage to the building, when you do your renovations discuss with the contractor better drainage management options as diverting as much roof and ground drainage from the foundation, supports or under the building will help protect the cottage from movement/damage,

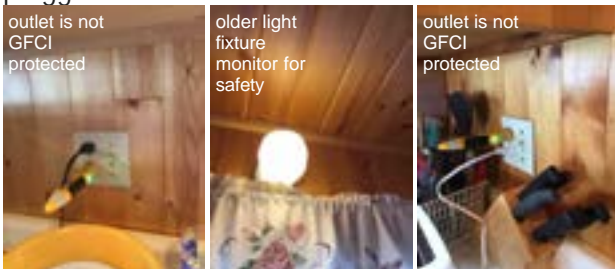
4. Marginal Electrical: 110 VAC - outlets are not GFCI protected near the sink take care if using appliances plugged into outlets near the sink as there is no GFCI protection at outlets

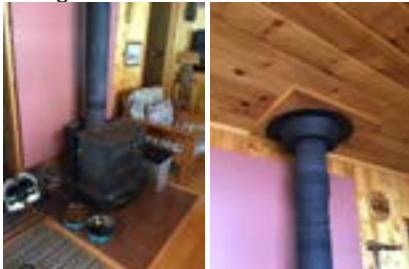
7. Marginal HVAC Source: as discussed wood stove does not meet WETT safety standards - we recommend not using the wood stove in it's current condition

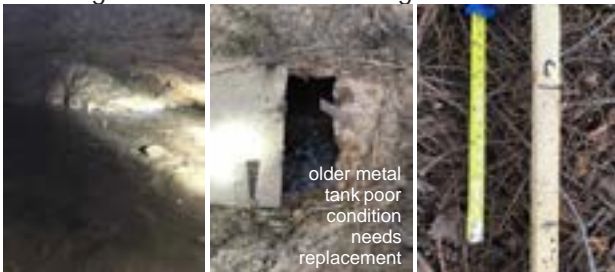
1. Marginal Method of Inspection: Flow test - 5 inch increase after 18 min, the flow test had to be stopped as the sewage level was rising too quickly and was close to overflowing, the drainage is not draining to the septic bed (if there is even a drainage bed we cannot confirm the presence of a septic bed), using the water/toilet too often will lead to back up or overflow, we recommend not using the washing machine as the drainage could cause overflow

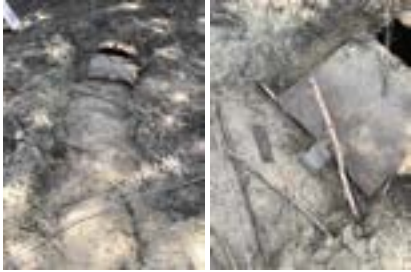
Tank: Metal - older metal tank well past it's life expectancy, tank may have damage and sewage could be leaking into the ground, the condition of the tank was discussed, the tank needs replacement, taking good care of the septic may help you get some more time out of it,

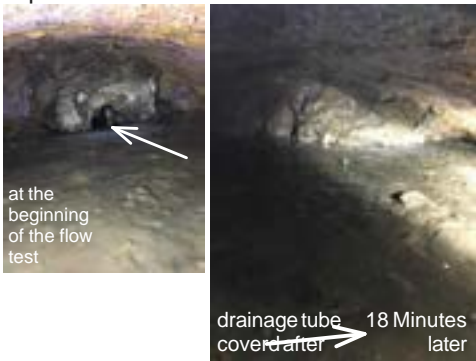
Baffles: None - there are no baffles and hard waste will be getting out to the drainage bed and plugging the tube/drainage bed, this can lead to back up or overflow, the septic tank needs replacement
