Clearview Home Inspection

Owen Sound
Huntsville, Ontario P2A1T5

Prepared for: Sample

11:40 February 14, 2022

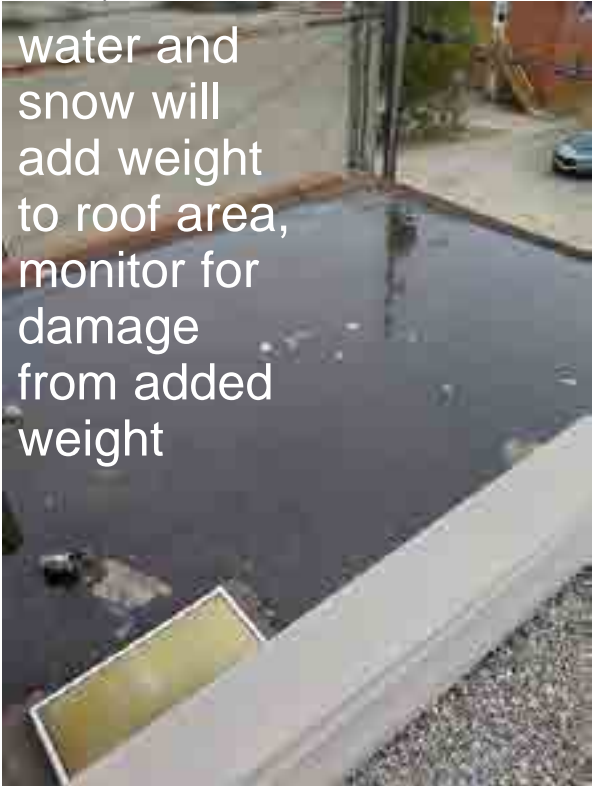
Lower (car port) roof (continued)

5. Lower (car port) roof water covered

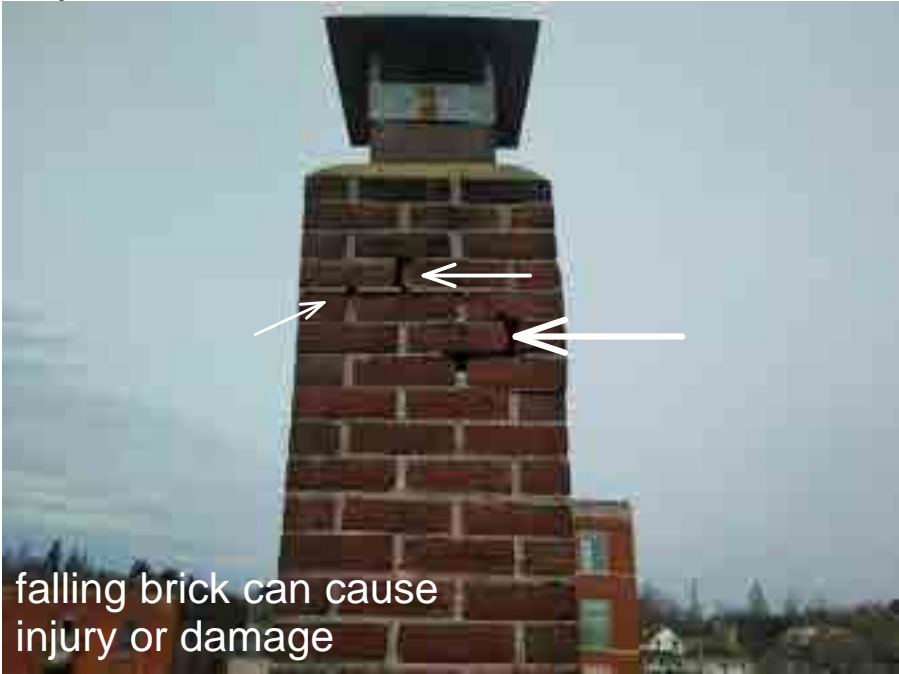
Chimney: (continued)

on a lean,
poor
condition,
could
damage
other roof
areas

damaged and
missing grouting,
,needs repair or
removal

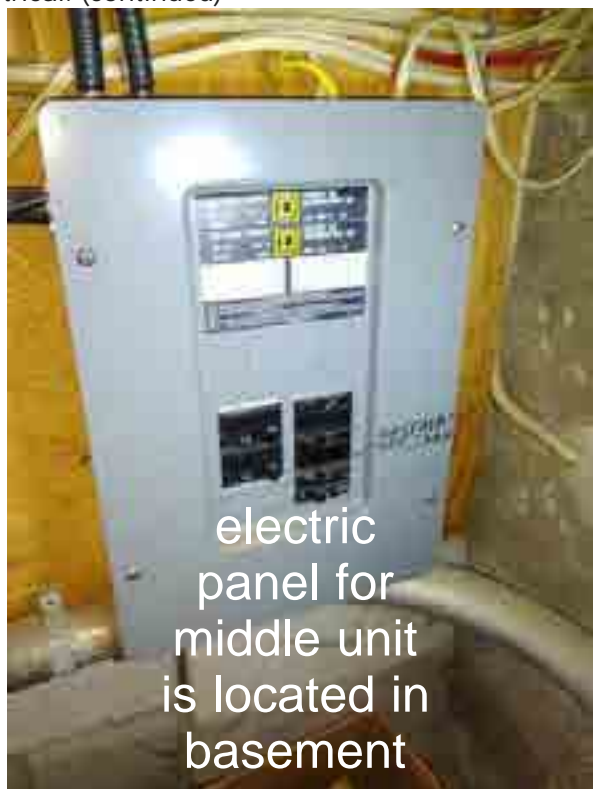
electric
panel for
middle unit
is located in
basement

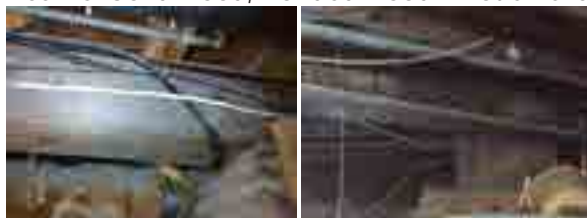
4. Acceptable Beams: Solid wood, Bonded wood - not all areas of the beam are visible for inspection

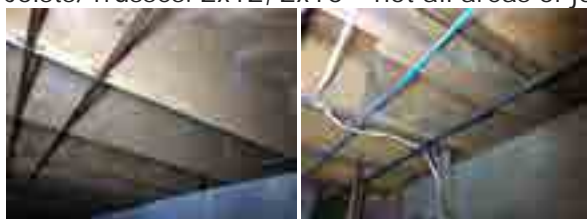
5. Acceptable Bearing Walls: Block
6. Acceptable Joists/Trusses: 2x12, 2x10 - not all areas of joist are visible for inspection

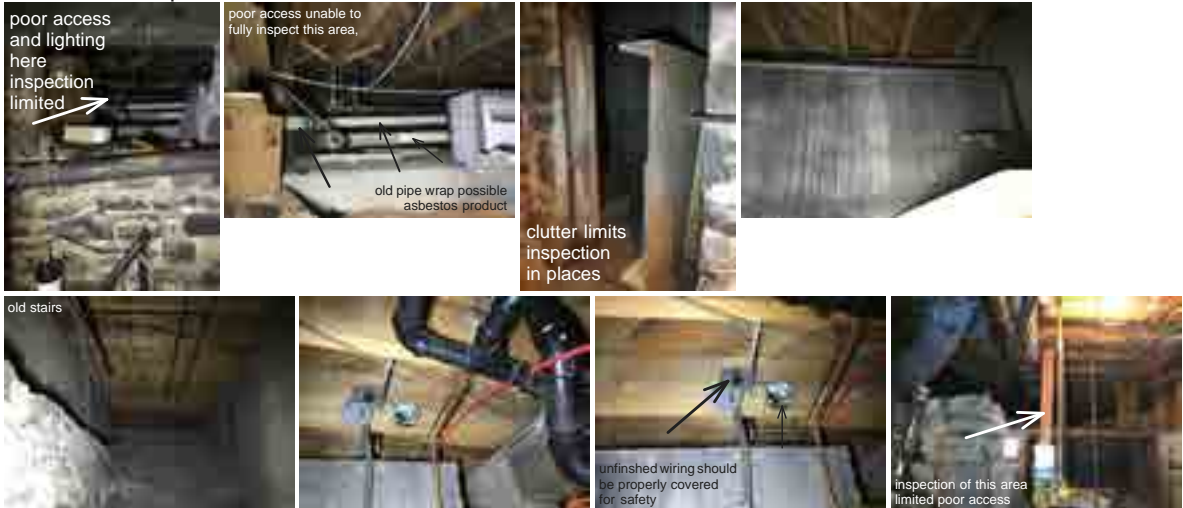
1. Not Inspected Unable to Inspect: 30%

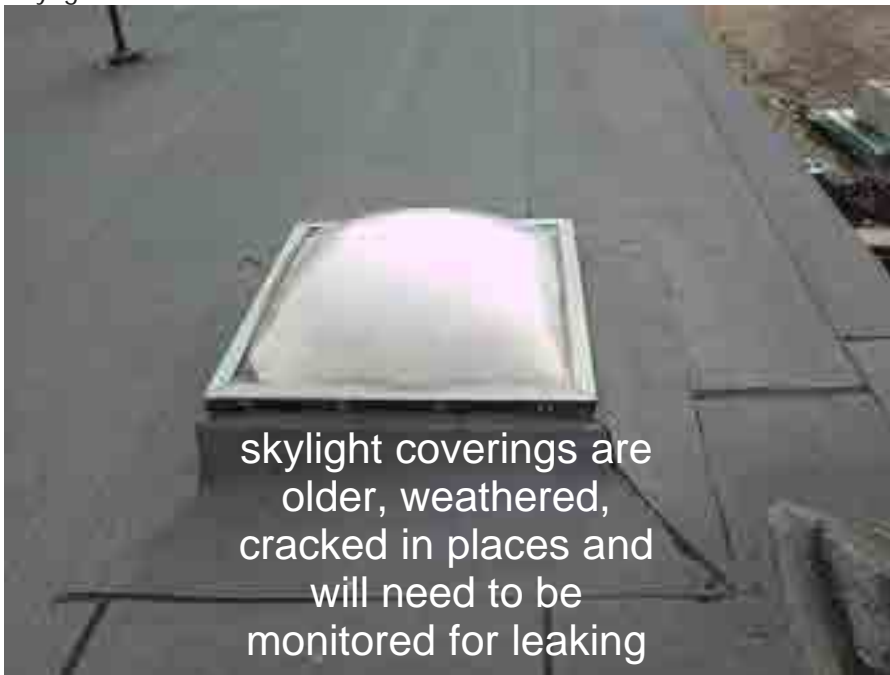
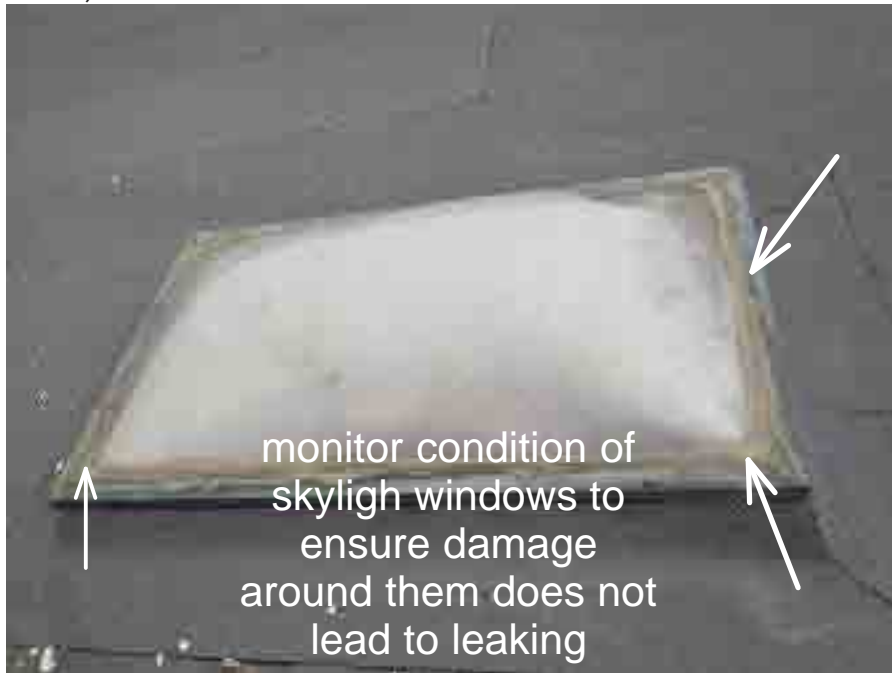
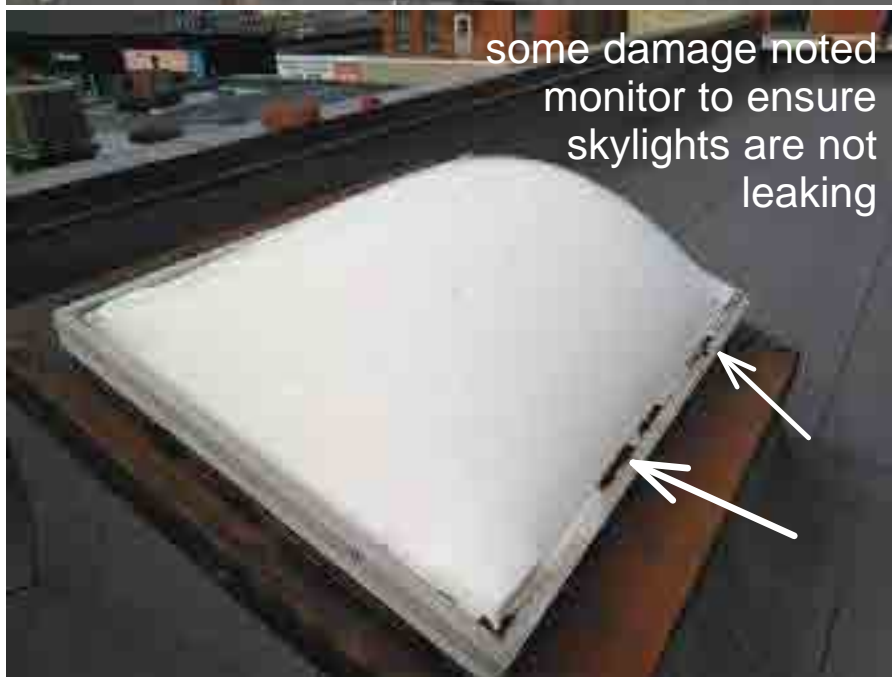
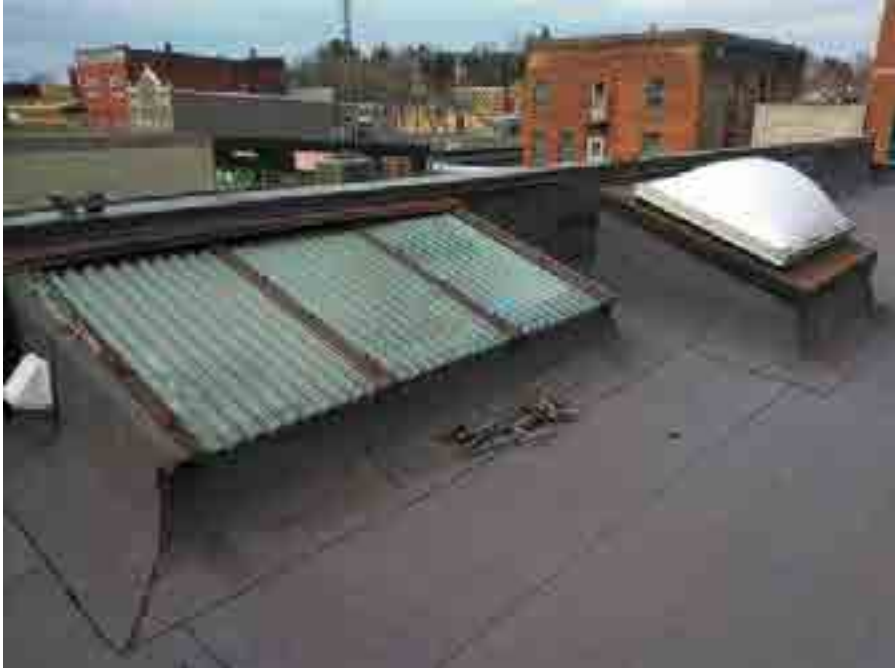
Skylights: (continued)

4. Type: Flat
5. Approximate Age: confirm age of roof with owner
6. Marginal Skylights: Plastic

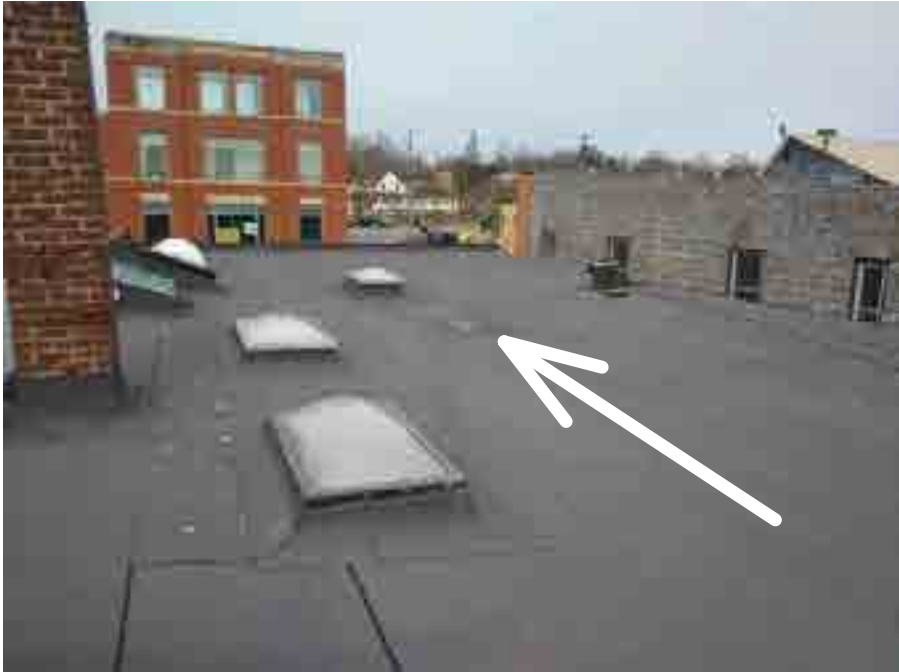
8. Acceptable Roof Drains: Surface

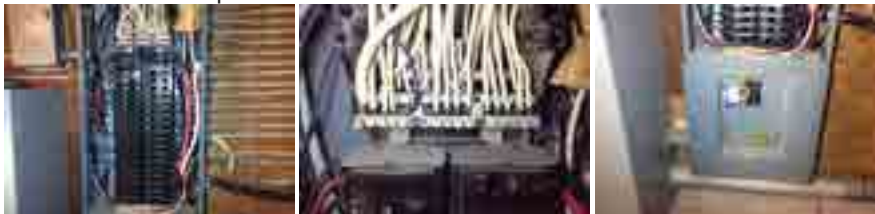
Back room Electric Panel

8. Acceptable Manufacturer: Square D

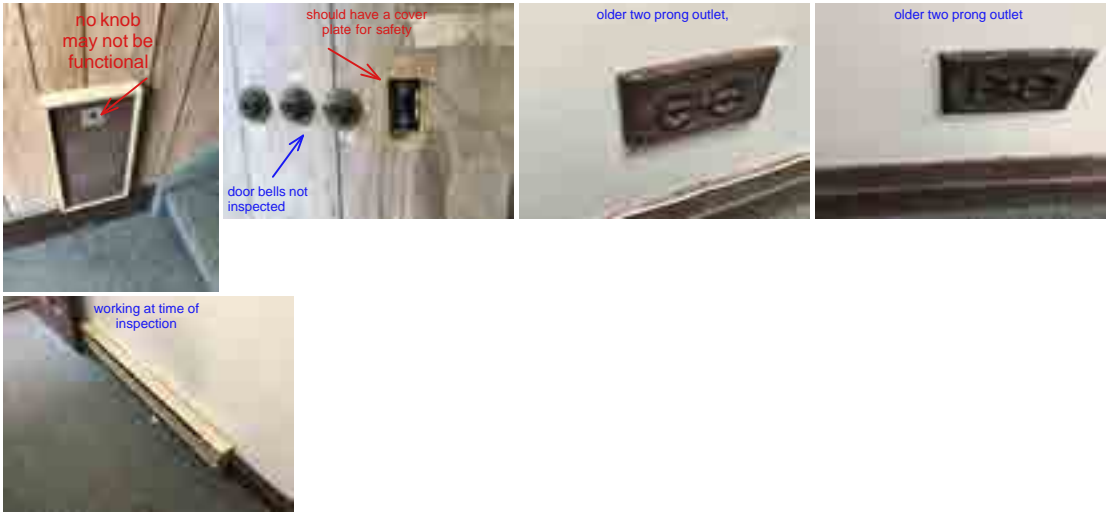
9. Not Inspected Electrical: older

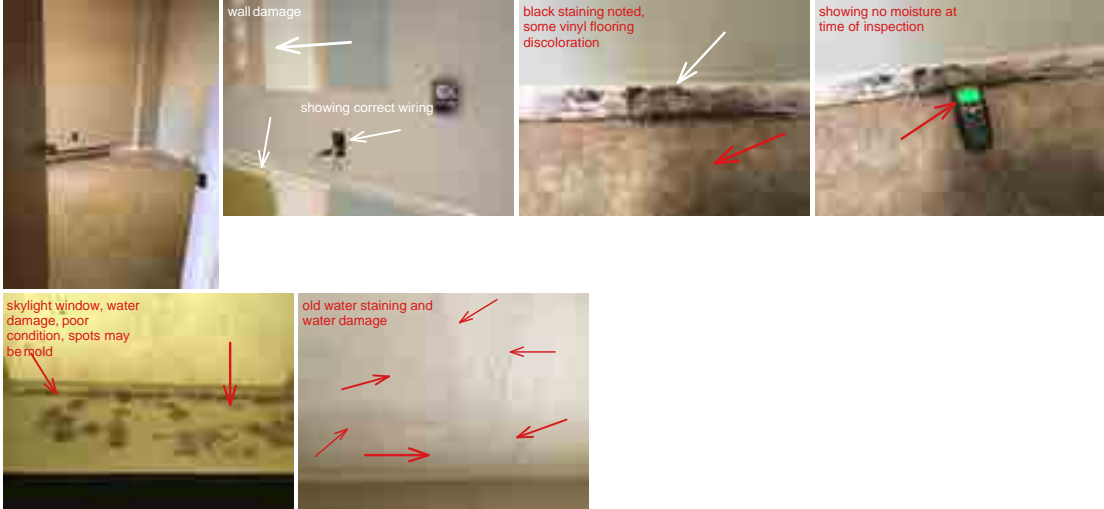
29. Marginal First right room see pictures

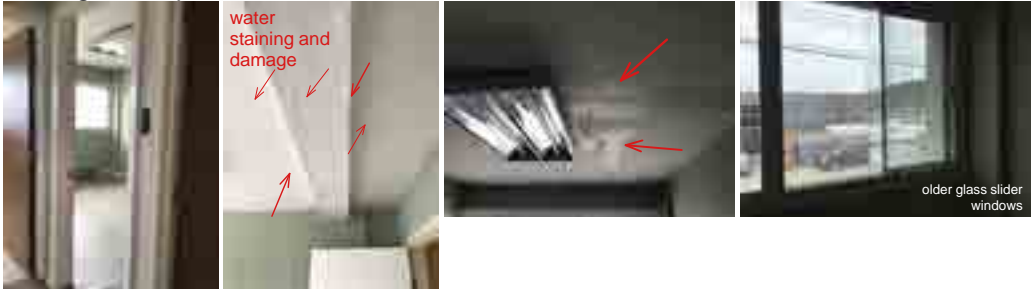
30. Marginal End right see pictures

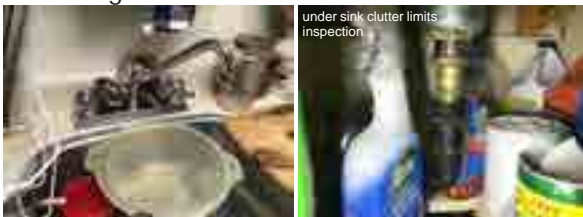
16. Not Inspected Plumbing/Fixtures:

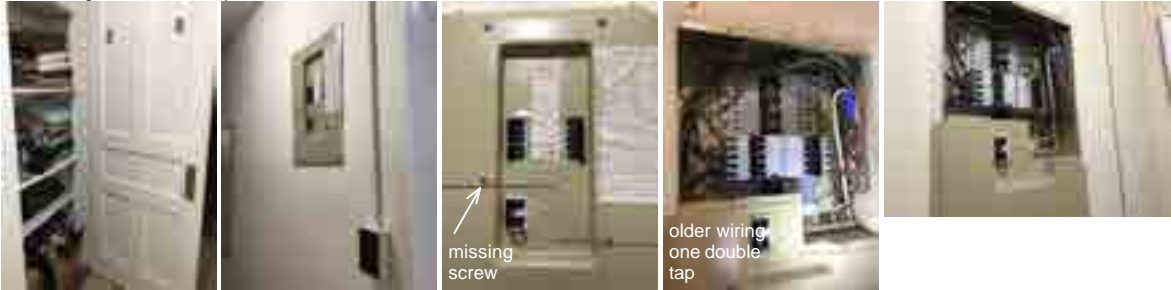
23. Marginal Hallway area see pictures

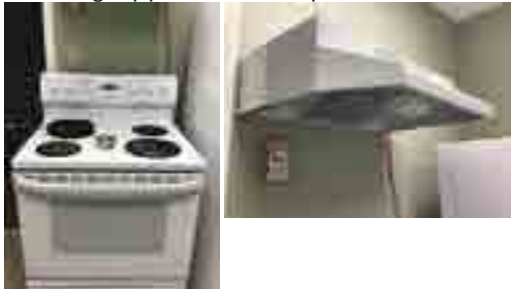
12. Not Inspected Cooking Appliances: Hotpoint

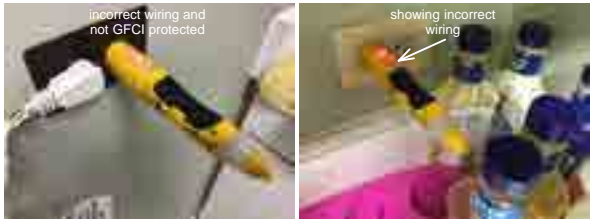
15. Marginal

Electrical: 110 VAC

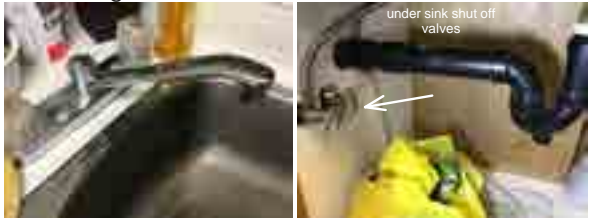
16. Acceptable

Plumbing/Fixtures: older fixture

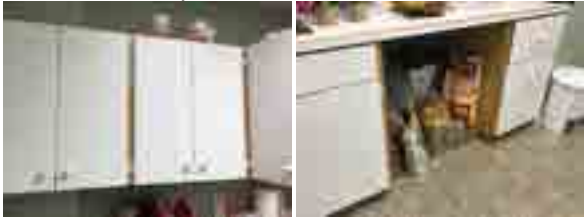
18. Acceptable Cabinets: see picture

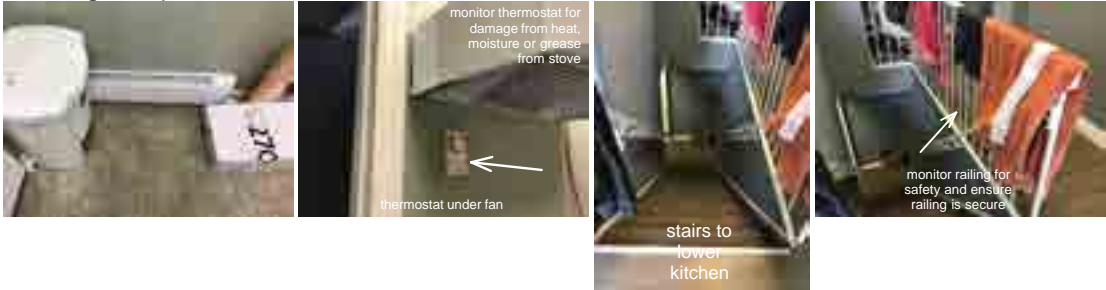
23. Not Inspected Heating see pictures

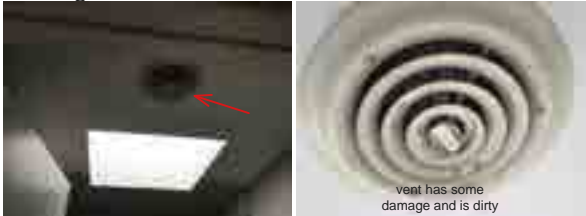
Main Bathroom
24. Acceptable

Ceiling: Paint

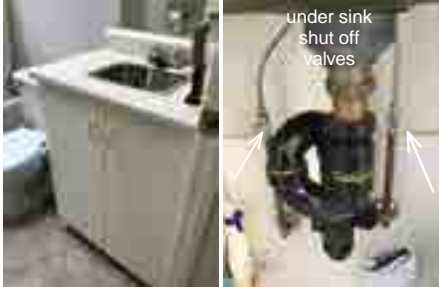
30. Acceptable

Counter/Cabinet: see picture

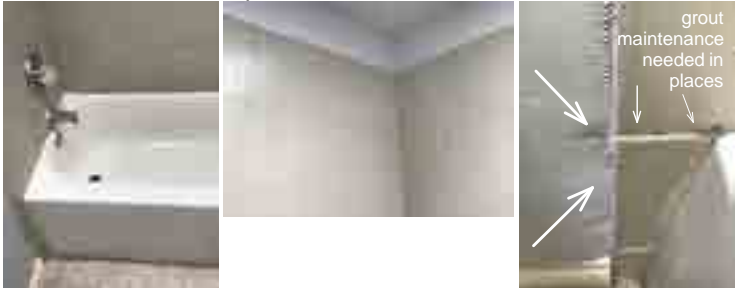
31. Acceptable

Tub/Surround: see pictures

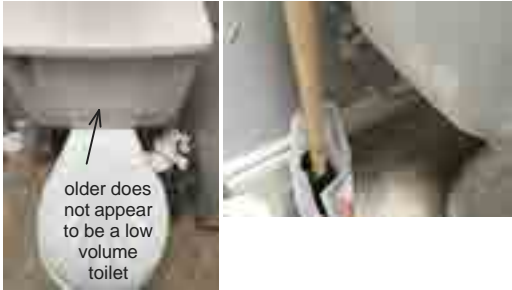
32. Acceptable Toilets: not ow volume

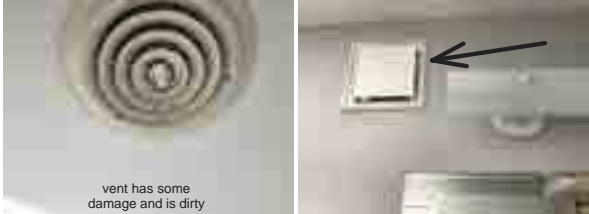
34. Not Inspected Ventilation: cannot confirm fan venting, proper venting is to exterior side of the building

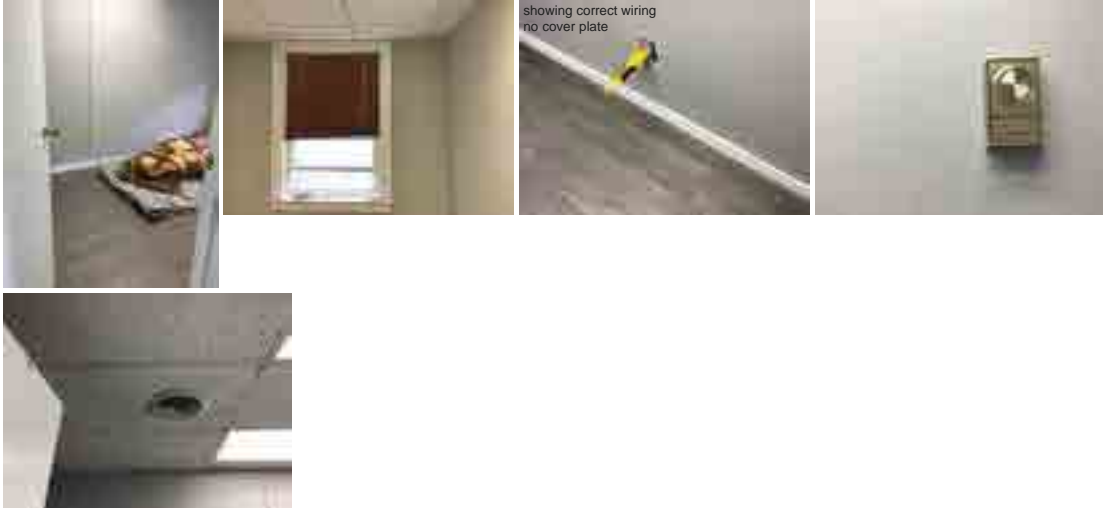
35. Acceptable First bedroom see pictures

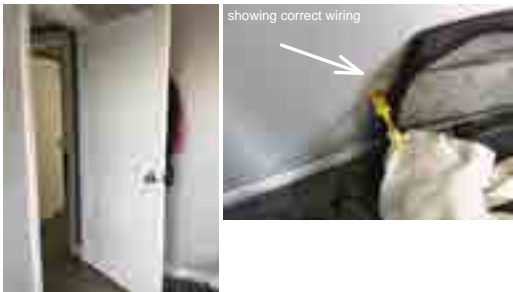
36. Acceptable Second bedroom see pictures

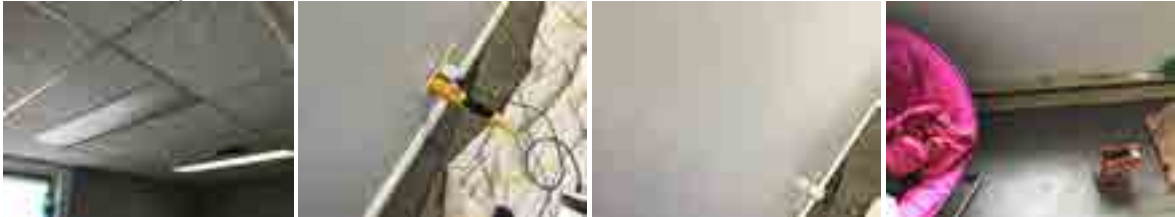
38. Acceptable Bedroom see pictures

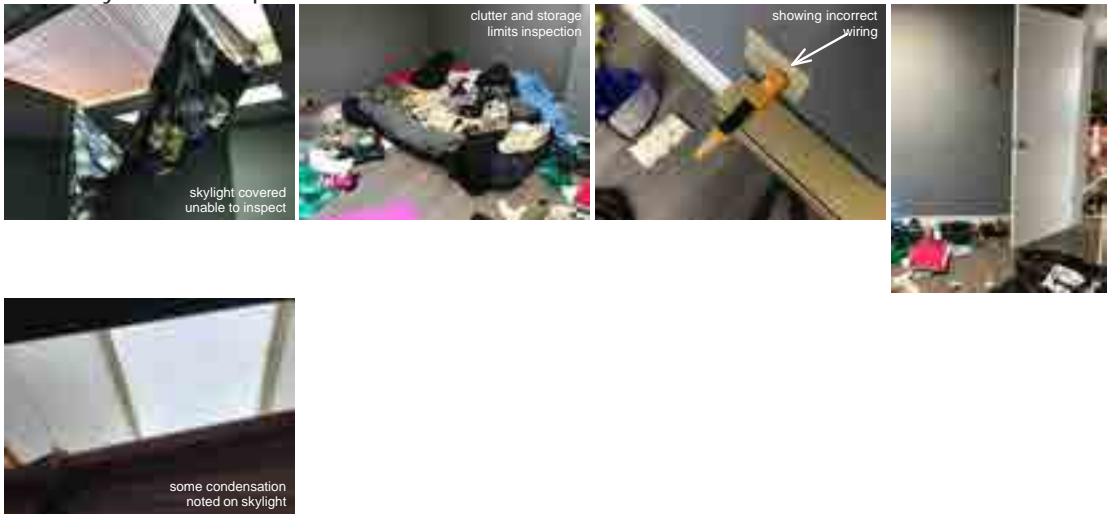
39. Acceptable

Room by stairs see pictures

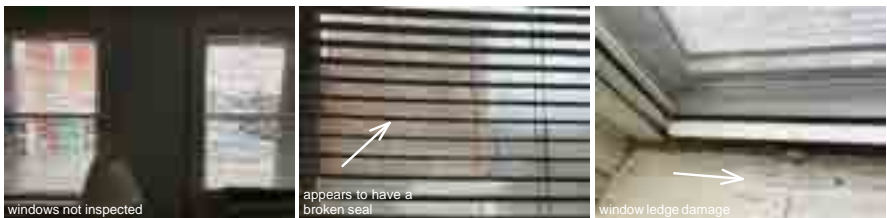
6. Marginal Windows: older aluminum

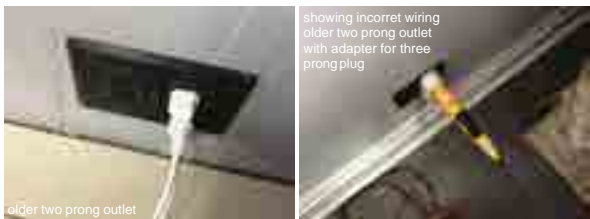
7. Marginal Electrical: 110 VAC

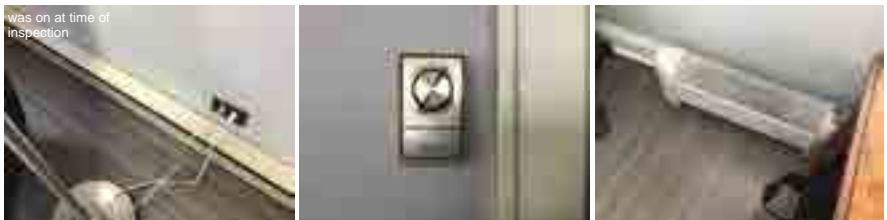
8. Acceptable HVAC Source: baseboard

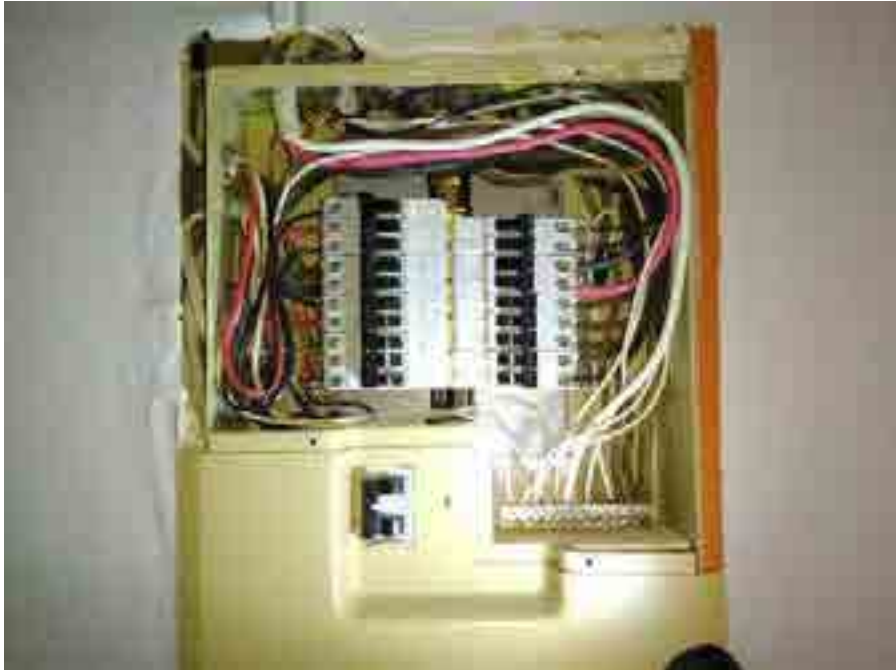
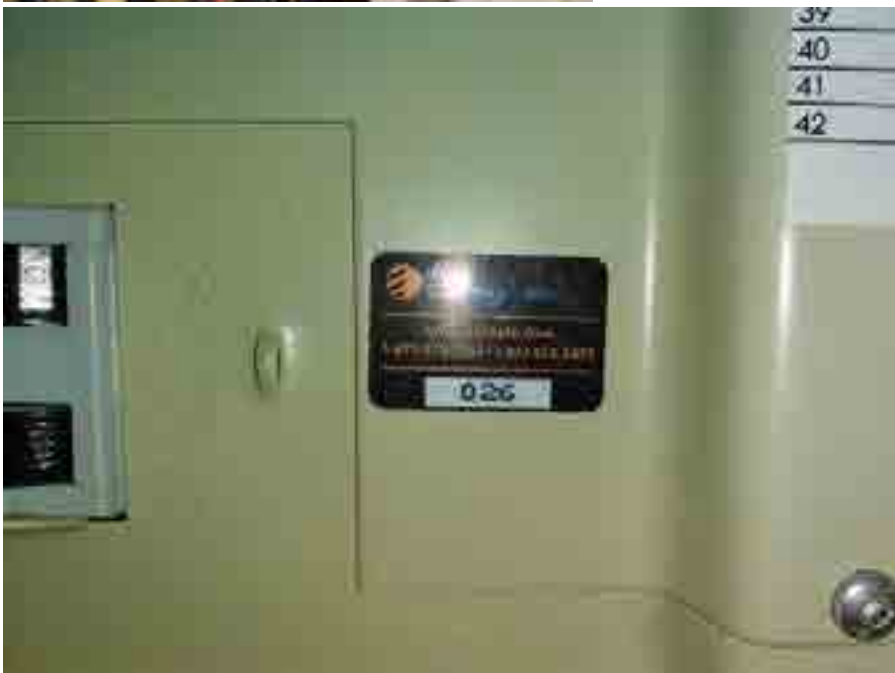
9. Acceptable Hallway area see pictures

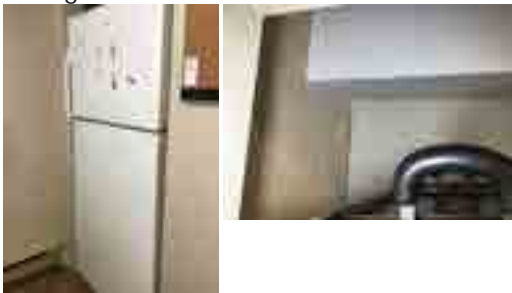
11. Not Inspected Refrigerator:

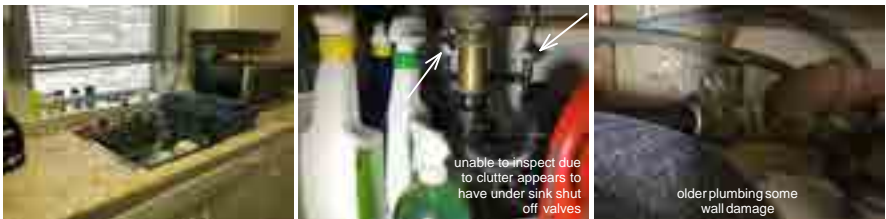
12. Acceptable Sink: Stainless Steel

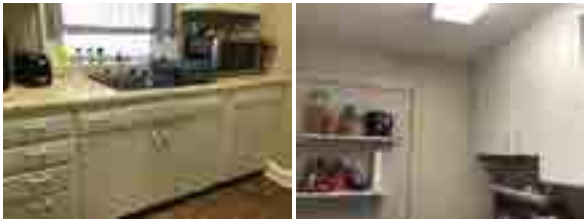
16. Acceptable Cabinets: older wood

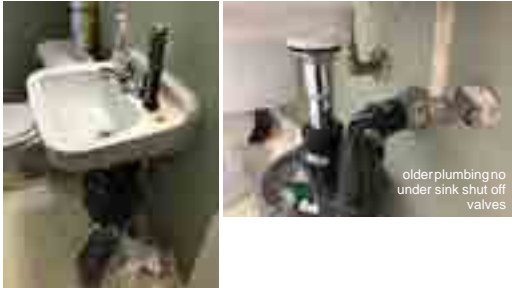
27. Acceptable Sink/Basin: wall mount

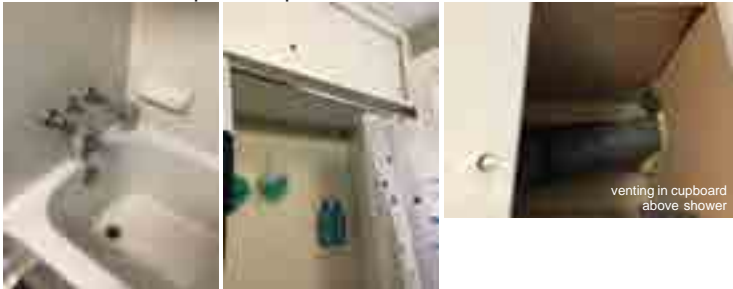
28. Acceptable Tub/Surround: pieced plastic

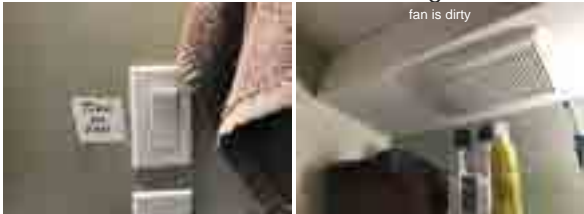
31. Not Inspected Ventilation: cannot confirm venting

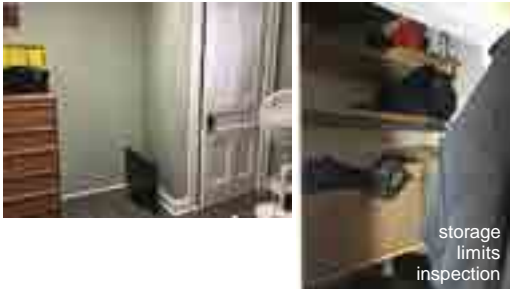
34. Acceptable Walls: Paint
